**EN1 - Argyle Street – London Plane Trees**

### Argyle Street, Picton

## ARBORICULTURAL ASSESSMENT REPORT

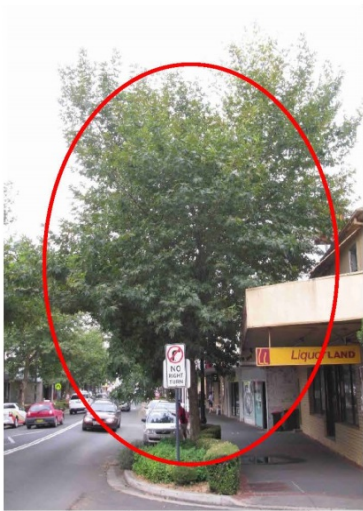
<b>TREE NUMBER 1</b> Next to Liquorland store	<b>BOTANICAL NAME:</b> Platanus x hybrida	<b>COMMON NAME:</b> London Plane Tree

<p data-bbox="272 1160 643 1209">Shows the tree from a distance which in good health and density, however it is lifting pavement and overhanging the awning.</p>	<b>DBH (mm) Diameter at Breast Height</b>	400mm	The tree assessed was evaluated on its own merits, health, structure, density, species and age of the specimen, were all taken into consideration as part of the audit process.
	<b>SRZ Required</b>	Not	
	<b>TPZ Required</b>	Applicable	Close and physical examination of the trees, trunk and foliage indicated the tree to be in Good health, structural condition and density. The tree's upper canopy/foliage appeared to be in Good health and vigour.
	<b>Tree to be retained Yes / No</b>	No	
	<b>Estimated Height (metres)</b>	12m	
	<b>Crown Spread (metres)</b>	10 x 10m	
	<b>Age Class</b>	Mature

<b>Canopy percentage</b>	100%	
	<b>Health</b>	Good	
	<b>Structural Condition</b>	Good	<b>Recommendation:</b> Consideration should be taken to have this tree removed and replaced with an appropriate street tree species, whilst it is juvenile and minor in size it has already caused major damage to pavements, roof awnings, kerb and gutter, underground services and may result in litigation from trip hazards form seed balls or pavement displacement. These trees have no room in their current position to reach maturity without causing many expensive issues.
<b>Ecological Value</b>	Nil		
<b>Visual amenity</b>	High		
<b>SULE Rating</b>	3B

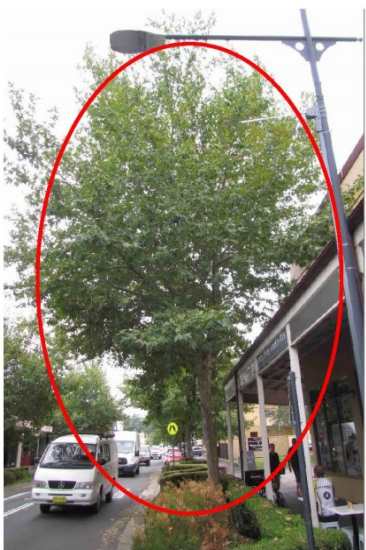
<b>TREE NUMBER 2</b> Front of Medi Specs shop.	<b>BOTANICAL NAME:</b> Platanus hybrida	<b>COMMON NAME:</b> London Plane Tree

<p>Shows the tree in a formal garden bed next to Medi Specs shop overhanging the awning.</p>

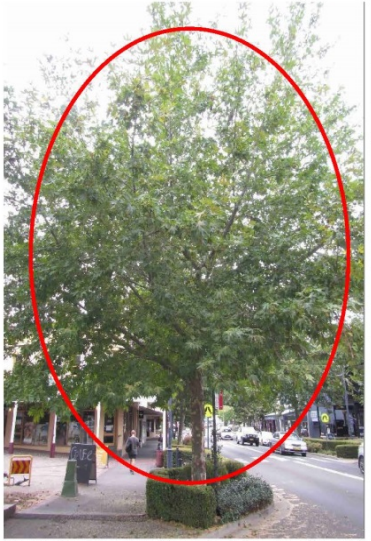
<b>TREE NUMBER 3</b> Near pedestrian crossing	<b>BOTANICAL NAME:</b> Platanus hybrida	<b>COMMON NAME:</b> London Plane Tree

<p data-bbox="272 1160 643 1202">Shows the tree near the pedestrian crossing and open space courtyard near the shops.</p>

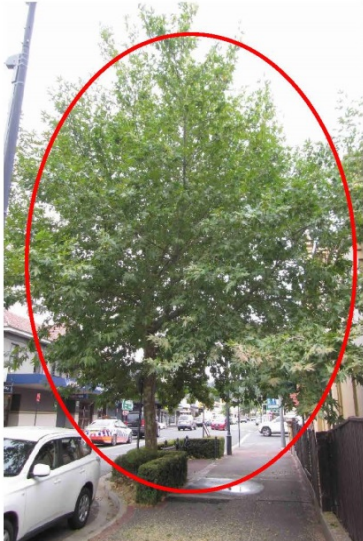
<b>TREE NUMBER 4</b> Along NAB bank	<b>BOTANICAL NAME:</b> Platanus hybrida	<b>COMMON NAME:</b> London Plane Tree

<p>Shows the tree alongside the NAB bank in good health within a formal garden bed.</p>

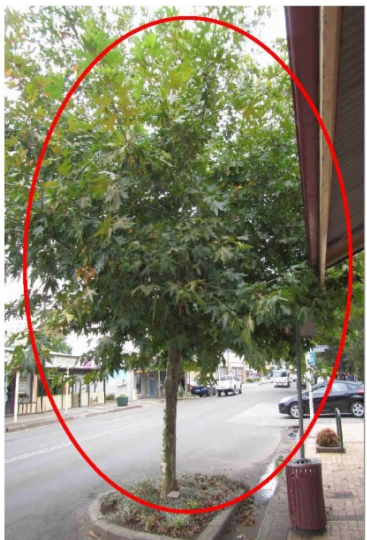
<b>TREE NUMBER 5</b> Front of Combined real-estate	<b>BOTANICAL NAME:</b> Platanus hybrida	<b>COMMON NAME:</b> London Plane Tree

<p data-bbox="271 1153 638 1207">Shows the tree from a distance overhanging and touching the buildings awning.</p>

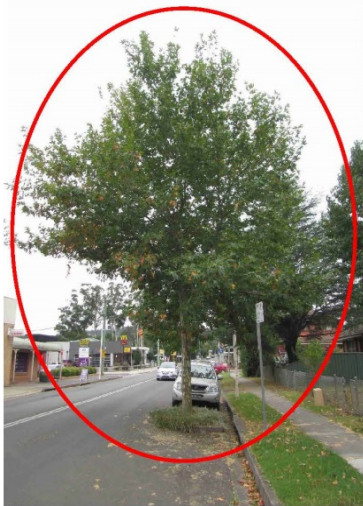
<b>TREE NUMBER 6</b> Front of Police Station	<b>BOTANICAL NAME:</b> Platanus hybrida	<b>COMMON NAME:</b> London Plane Tree

<p>Shows the tree from a distance with large leaves, seed pots and fine hairs all over the walk and roadway.</p>	<b>DBH (mm) Diameter at Breast Height</b>	310mm	The tree assessed was evaluated on its own merits, health, structure, density, species and age of the specimen, were all taken into consideration as part of the audit process.
	<b>SRZ Required</b>	Not Applicable	
	<b>TPZ Required</b>	Applicable	<b>Tree Assessment Summary- Good</b> , this Council street tree is generally healthy and free from the presence of major disease, obvious structural weaknesses, fungal or insect infestation.
	<b>Tree to be retained Yes / No</b>	No	
	<b>Estimated Height (metres)</b>	9m	Close and physical examination of the trees, trunk and foliage indicated the tree to be in Good health, structural condition and density. The tree's upper canopy/foilage appeared to be in Good health and vigour.

<b>Crown Spread (metres)</b>	8 x 8m	
	<b>Age Class</b>	Mature	Based on the trees present minor age, size, form, location within the roadway and predetermined large natural aesthetic size. Consideration of replacing it with a more appropriate species should be discussed due to on-going maintenance costs, damage to Council and private assets, health concerns from seed pod hairs, slip/trip hazard verses replacing with an appropriate species now.
	<b>Canopy percentage</b>	100%	
	<b>Health</b>	Good	
	<b>Structural Condition</b>	Good	<b>Recommendation:</b> Consideration should be taken to have this tree removed and replaced with an appropriate street tree species, whilst it is juvenile and minor in size it has already caused major damage to pavements, roof awnings, kerb and gutter, underground services and may result in litigation from trip hazards form seed balls or pavement displacement. These trees have no room in their current position to reach maturity without causing many expensive issues.

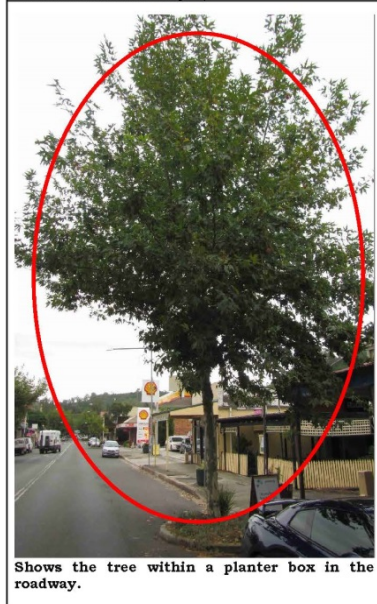
<b>TREE NUMBER 7</b> Front of Loan Market Shop	<b>BOTANICAL NAME:</b> Platanus hybrida	<b>COMMON NAME:</b> London Plane Tree

<p>Shows the tree within a planter box in the roadway.</p>

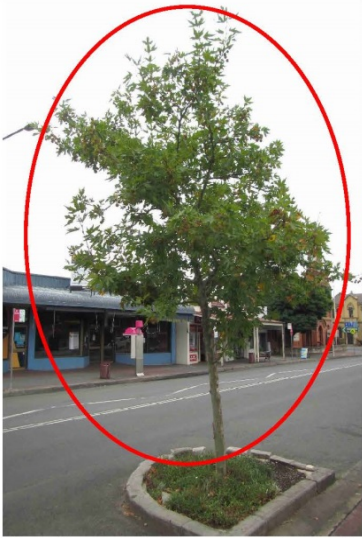
<b>TREE NUMBER 8</b> Front of Mac Credit Union	<b>BOTANICAL NAME:</b> Platanus hybrida	<b>COMMON NAME:</b> London Plane Tree

<b>DBH (mm) Diameter at Breast Height</b>	100mm	The tree assessed was evaluated on its own merits, health, structure, density, species and age of the specimen, were all taken into consideration as part of the audit process.
	<b>SRZ Required</b>	Not Applicable	
	<b>TPZ Required</b>	No	
	<b>Tree to be retained Yes / No</b>	<b>Tree Assessment Summary- Good</b> , this Council street tree is generally healthy and free from the presence of major disease, obvious structural weaknesses, fungal or insect infestation.	
	<b>Estimated Height (metres)</b>	3m	
	<b>Crown Spread (metres)</b>	3 x 3m	
	<b>Age Class</b>	Semi Mature	
	<b>Canopy percentage</b>	100%	
	<b>Health</b>	Good	
	<b>Structural Condition</b>	Good	
	<b>Ecological Value</b>	Nil	
<b>Visual amenity</b>	Moderate		
<b>SULE Rating</b>	3B	<b>Recommendation:</b> Consideration should be taken to have this tree removed and replaced with an appropriate street tree species, whilst it is juvenile and minor in size it has already caused major damage to pavements, roof awnings, kerb and gutter, underground services and may result in litigation from trip hazards form seed balls or pavement displacement. These trees have no room in their current position to reach maturity without causing many expensive issues.

Shows the tree within a planter box in the roadway in Front of Macarthur Credit Union.

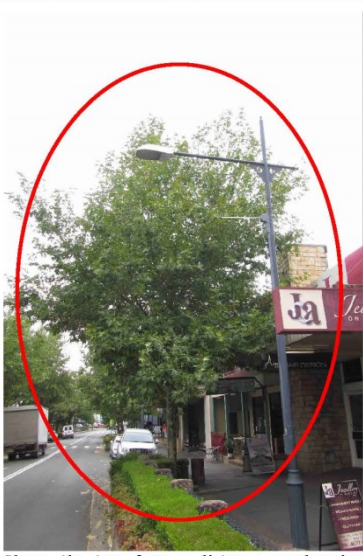
<b>TREE NUMBER 9</b> Front of Argyle hair studios	<b>BOTANICAL NAME:</b> Platanus hybrida	<b>COMMON NAME:</b> London Plane Tree

<p>Shows the tree from a distance overhanging Argyle hair studios shop front and awning.</p>	<b>DBH (mm) Diameter at Breast Height</b>	340mm	The tree assessed was evaluated on its own merits, health, structure, density, species and age of the specimen, were all taken into consideration as part of the audit process.
	<b>SRZ Required</b>	Not	
	<b>TPZ Required</b>	Applicable	
	<b>Tree to be retained Yes / No</b>	No	<b>Tree Assessment Summary- Good</b> , this Council street tree is generally healthy and free from the presence of major disease, obvious structural weaknesses, fungal or insect infestation.
	<b>Estimated Height (metres)</b>	10m	Close and physical examination of the trees, trunk and foliage indicated the tree to be in Good health, structural condition and density. The tree's upper canopy/foliage appeared to be in Good health and vigour.

<b>Crown Spread (metres)</b>	8 x 8m	
	<b>Age Class</b>	Mature	Based on the trees present minor age, size, form, location within the roadway and predetermined large natural aesthetic size. Consideration of replacing it with a more appropriate species should be discussed due to on-going maintenance costs, damage to Council and private assets, health concerns from seed pod hairs, slip/trip hazard verses replacing with an appropriate species now.
	<b>Canopy percentage</b>	100%	
	<b>Health</b>	Good	
	<b>Structural Condition</b>	Good	
<b>Ecological Value</b>	Nil	<b>Recommendation:</b> Consideration should be taken to have this tree removed and replaced with an appropriate street tree species, whilst it is juvenile and minor in size it has already caused major damage to pavements, roof awnings, kerb and gutter, underground services and may result in litigation from trip hazards from seed balls or pavement displacement. These trees have no room in their current position to reach maturity without causing many expensive issues.

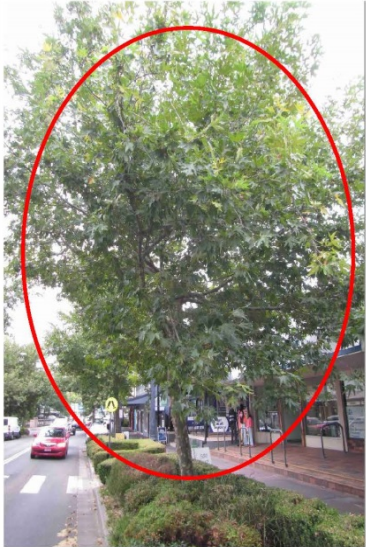
<b>TREE NUMBER 10</b> Garden bed near crossing	<b>BOTANICAL NAME:</b> Platanus hybrida	<b>COMMON NAME:</b> London Plane Tree

<p>Shows the tree near the pedestrian crossing in good health. This tree is less than a quarter of its natural aesthetic size and form.</p>	<b>DBH (mm) Diameter at Breast Height</b>	310mm	The tree assessed was evaluated on its own merits, health, structure, density, species and age of the specimen, were all taken into consideration as part of the audit process.  <b>Tree Assessment Summary- Good</b> , this Council street tree is generally healthy and free from the presence of major disease, obvious structural weaknesses, fungal or insect infestation.  Close and physical examination of the trees, trunk and foliage indicated the tree to be in Good health, structural condition and density. The tree's upper canopy/foliage appeared to be in Good health and vigour.  Based on the trees present minor age, size, form, location within the roadway and predetermined large natural aesthetic size. Consideration of replacing it with a more appropriate species should be discussed due to on-going maintenance costs, damage to Council and private assets, health concerns from seed pod hairs, slip/trip hazard verses replacing with an appropriate species now.  <b>Recommendation:</b> Consideration should be taken to have this tree removed and replaced with an appropriate street tree species, whilst it is juvenile and minor in size it has already caused major damage to pavements, roof awnings, kerb and gutter, underground services and may result in litigation from trip hazards form seed balls or pavement displacement. These trees have no room in their current position to reach maturity without causing many expensive issues.

<b>SRZ Required</b>	Not Applicable	
	<b>TPZ Required</b>	No	
	<b>Tree to be retained Yes / No</b>	No	
	<b>Estimated Height (metres)</b>	10m	
	<b>Crown Spread (metres)</b>	8 x 8m	
	<b>Age Class</b>	Mature	
	<b>Canopy percentage</b>	100%	
	<b>Health</b>	Good	
	<b>Structural Condition</b>	Good	
<b>Ecological Value</b>	Nil		
<b>Visual amenity</b>	High		
<b>SULE Rating</b>	3B

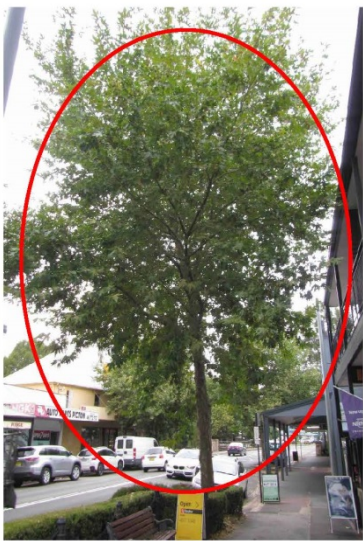
<b>TREE NUMBER 11</b> Front of NRMA Office	<b>BOTANICAL NAME:</b> Platanus hybrida	<b>COMMON NAME:</b> London Plane Tree

<p>Shows the tree in front of the NRMA office with raised pedestrian walkway from root mass movement.</p>	<b>DBH (mm) Diameter at Breast Height</b>	390mm	The tree assessed was evaluated on its own merits, health, structure, density, species and age of the specimen, were all taken into consideration as part of the audit process.
	<b>SRZ Required</b>	Not	
	<b>TPZ Required</b>	Applicable	Close and physical examination of the trees, trunk and foliage indicated the tree to be in Good health, structural condition and density. The tree's upper canopy/foilage appeared to be in Good health and vigour.
	<b>Tree to be retained Yes / No</b>	No	
	<b>Estimated Height (metres)</b>	10m	
	<b>Crown Spread (metres)</b>	8 x 8m	
	<b>Age Class</b>	Mature	
	<b>Canopy percentage</b>	100%	<b>Recommendation:</b> Consideration should be taken to have this tree removed and replaced with an appropriate street tree species, whilst it is juvenile and minor in size it has already caused major damage to pavements, roof awnings, kerb and gutter, underground services and may result in litigation from trip hazards form seed balls or pavement displacement. These trees have no room in their current position to reach maturity without causing many expensive issues.

<b>Health</b>	Good	
	<b>Structural Condition</b>	Good	
<b>Ecological Value</b>	Nil		
<b>Visual amenity</b>	High		
<b>SULE Rating</b>	3B

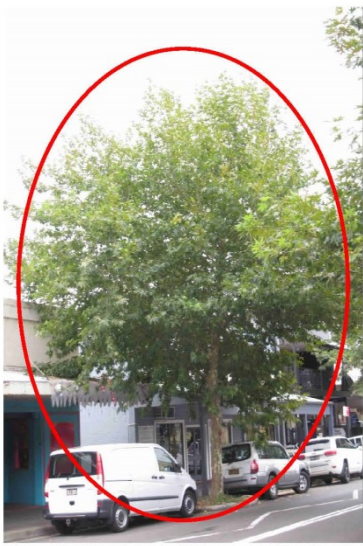
<b>TREE NUMBER 12</b> Front of Living Beautiful Shop	<b>BOTANICAL NAME:</b> Platanus hybrida	<b>COMMON NAME:</b> London Plane Tree

<p>Shows the tree from a distance overhanging the Living Beautiful Life Shop front and awning.</p>	<b>DBH (mm) Diameter at Breast Height</b>	350mm	The tree assessed was evaluated on its own merits, health, structure, density, species and age of the specimen, were all taken into consideration as part of the audit process.
	<b>SRZ Required</b>	Not	
	<b>TPZ Required</b>	Applicable	Close and physical examination of the trees, trunk and foliage indicated the tree to be in Good health, structural condition and density. The tree's upper canopy/foilage appeared to be in Good health and vigour.
	<b>Tree to be retained Yes / No</b>	No	
	<b>Estimated Height (metres)</b>	10m	
	<b>Crown Spread (metres)</b>	9 x 9m	
	<b>Age Class</b>	Mature	
	<b>Canopy percentage</b>	100%	<b>Recommendation:</b> Consideration should be taken to have this tree removed and replaced with an appropriate street tree species, whilst it is juvenile and minor in size it has already caused major damage to pavements, roof awnings, kerb and gutter, underground services and may result in litigation from trip hazards form seed balls or pavement displacement. These trees have no room in their current position to reach maturity without causing many expensive issues.

<b>Health</b>	Good	
	<b>Structural Condition</b>	Good	
<b>Ecological Value</b>	Nil		
<b>Visual amenity</b>	High		
<b>SULE Rating</b>	3B

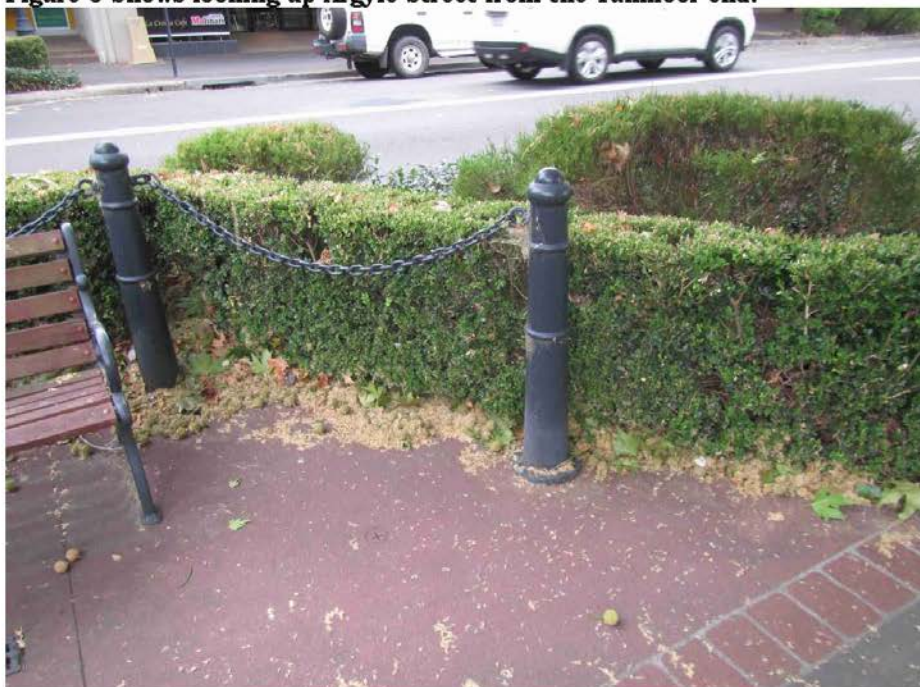
**Figure 7 Shows seed pods and seed hairs covering everything.**

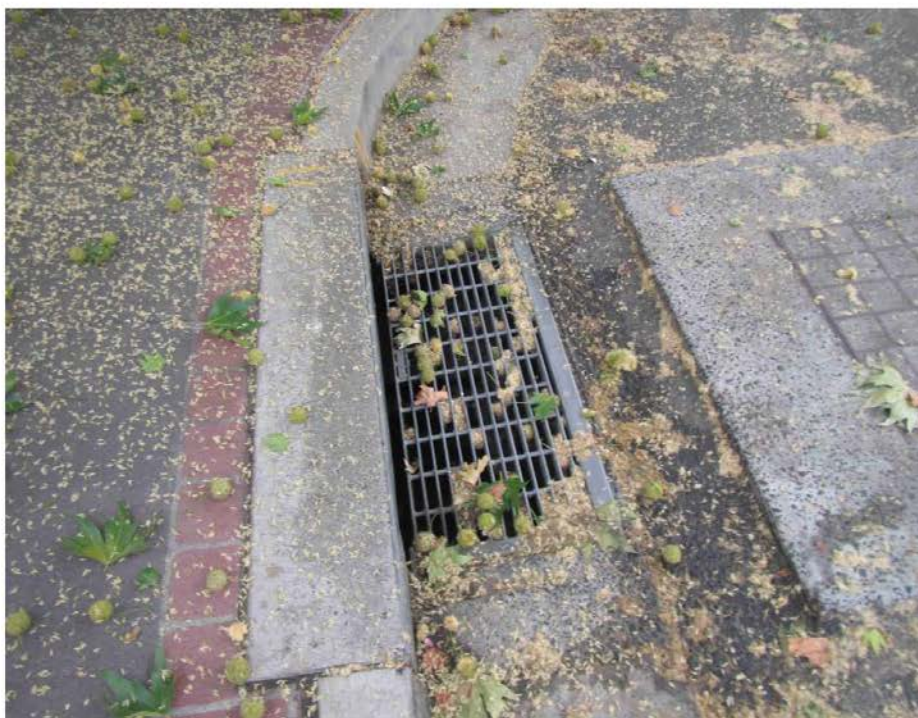
**Figure 8 Shows a street drain that would get covered by leaves and seed balls**

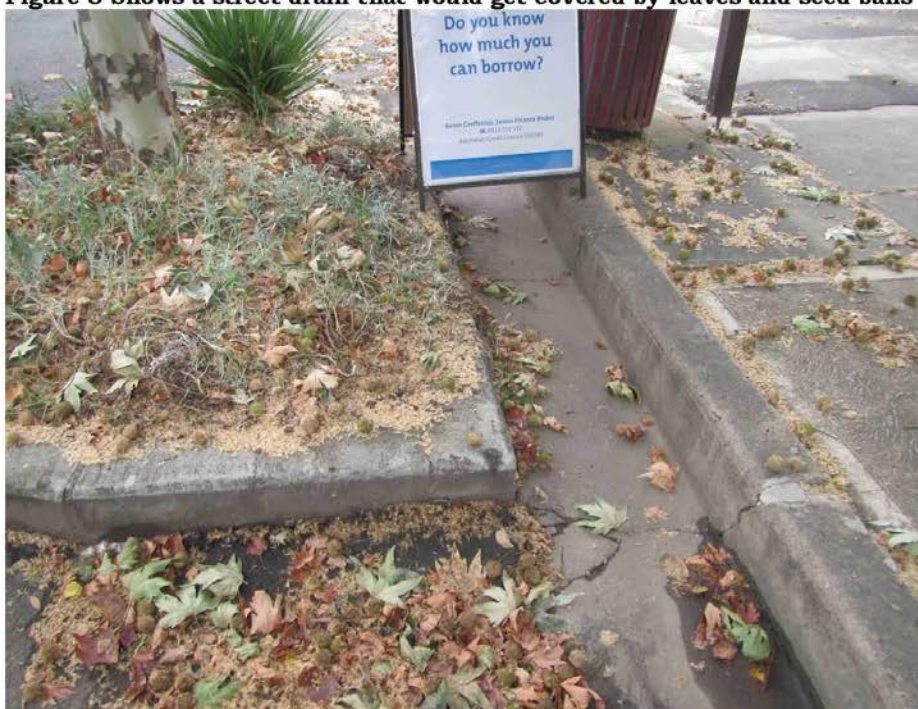
**Figure 9 Shows dropping leaves and extra maintenance to remove it.**

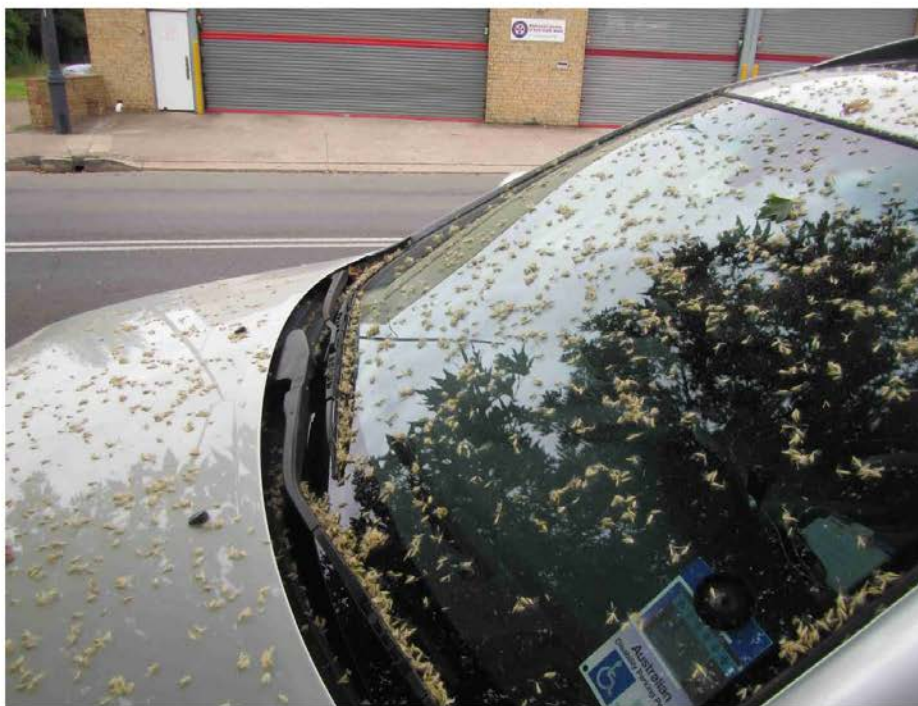
**Figure 10 Shows a car covered from seed hairs parked in Argyle Street.**

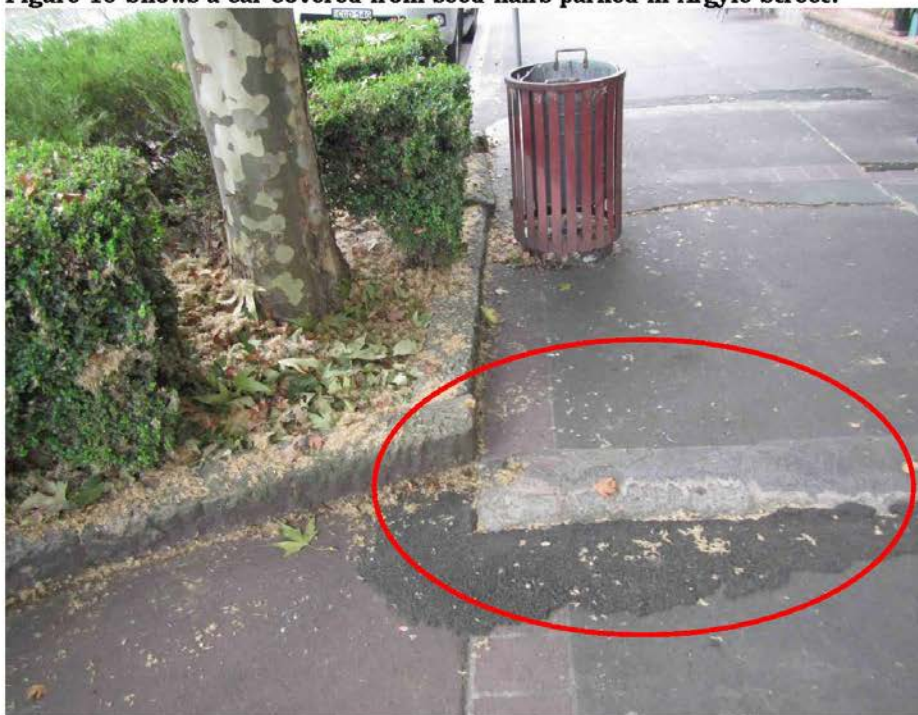
**Figure 11 Shows raised concrete that presents a major trip hazard.**

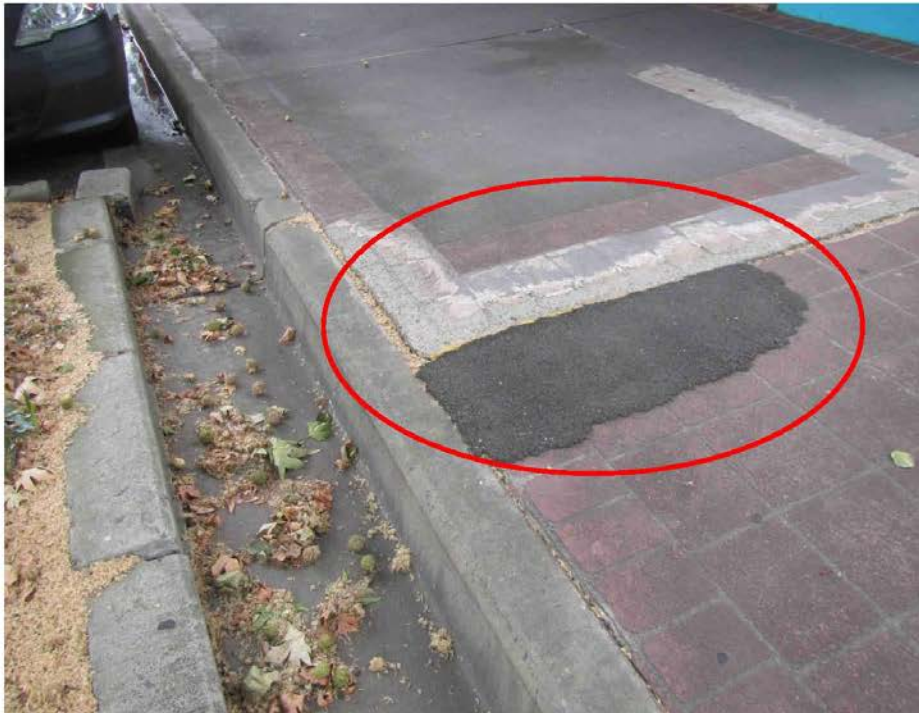
**Figure 12 Shows more raised concrete that has been shaved to reduce tripping**

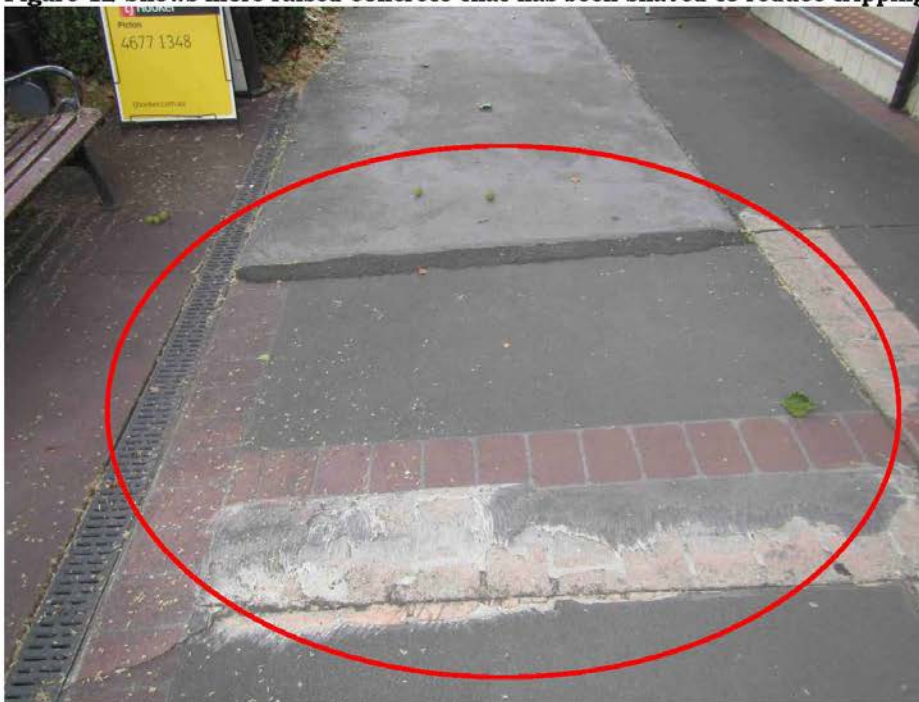
**Figure 13 Shows again trip hazards from lifting concrete.**
