STONEQUARRY CREEK (PICTON) FLOOD STUDY UPDATE FINAL VOLUME II

FIGURES

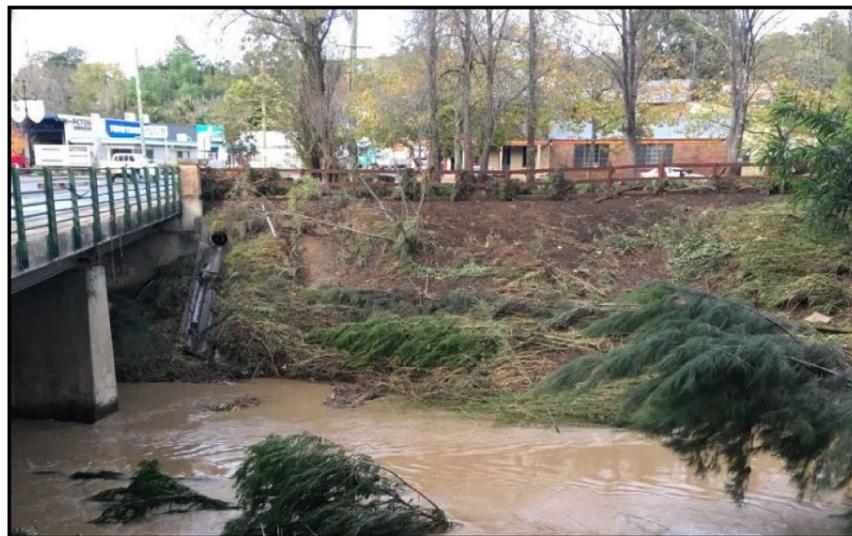
Stonequarry Creek at Argyle St Bridge, ABC 2016

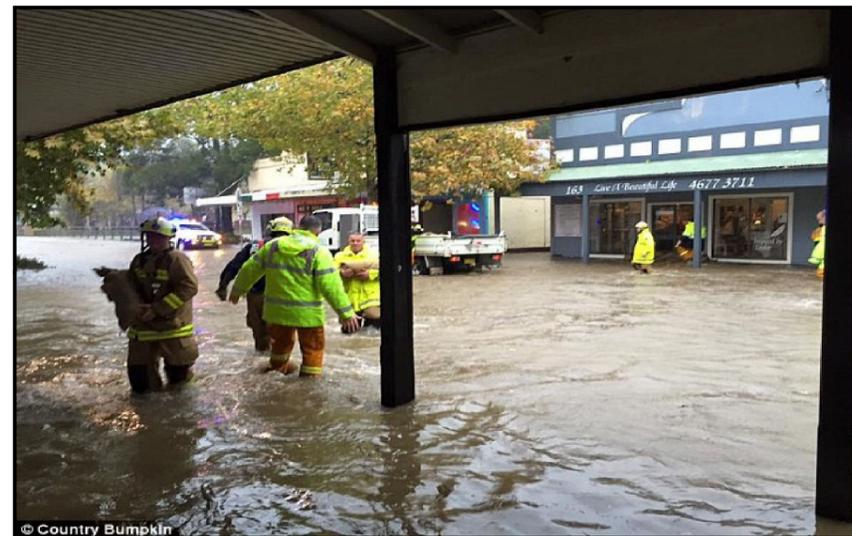
Argyle St - Flood height, Daily Mail 2016

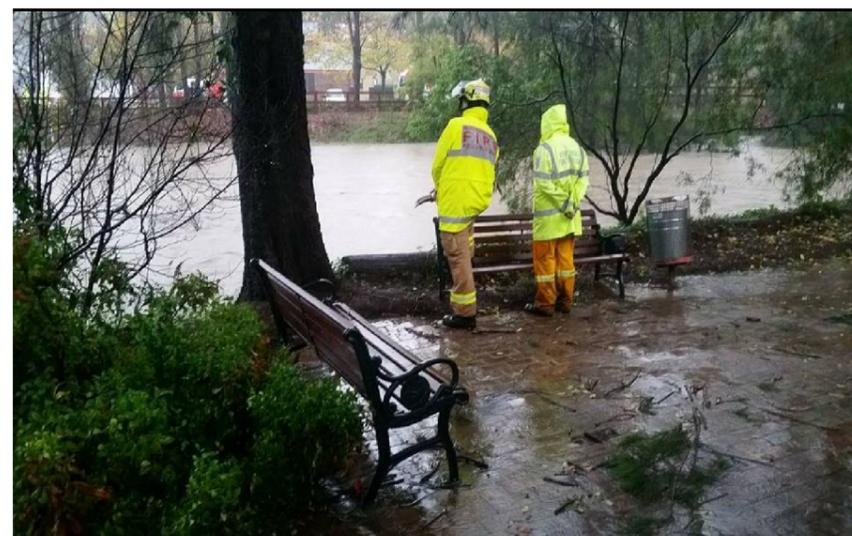
Stonequarry Creek in flood, Picton Fire and Rescue 2016

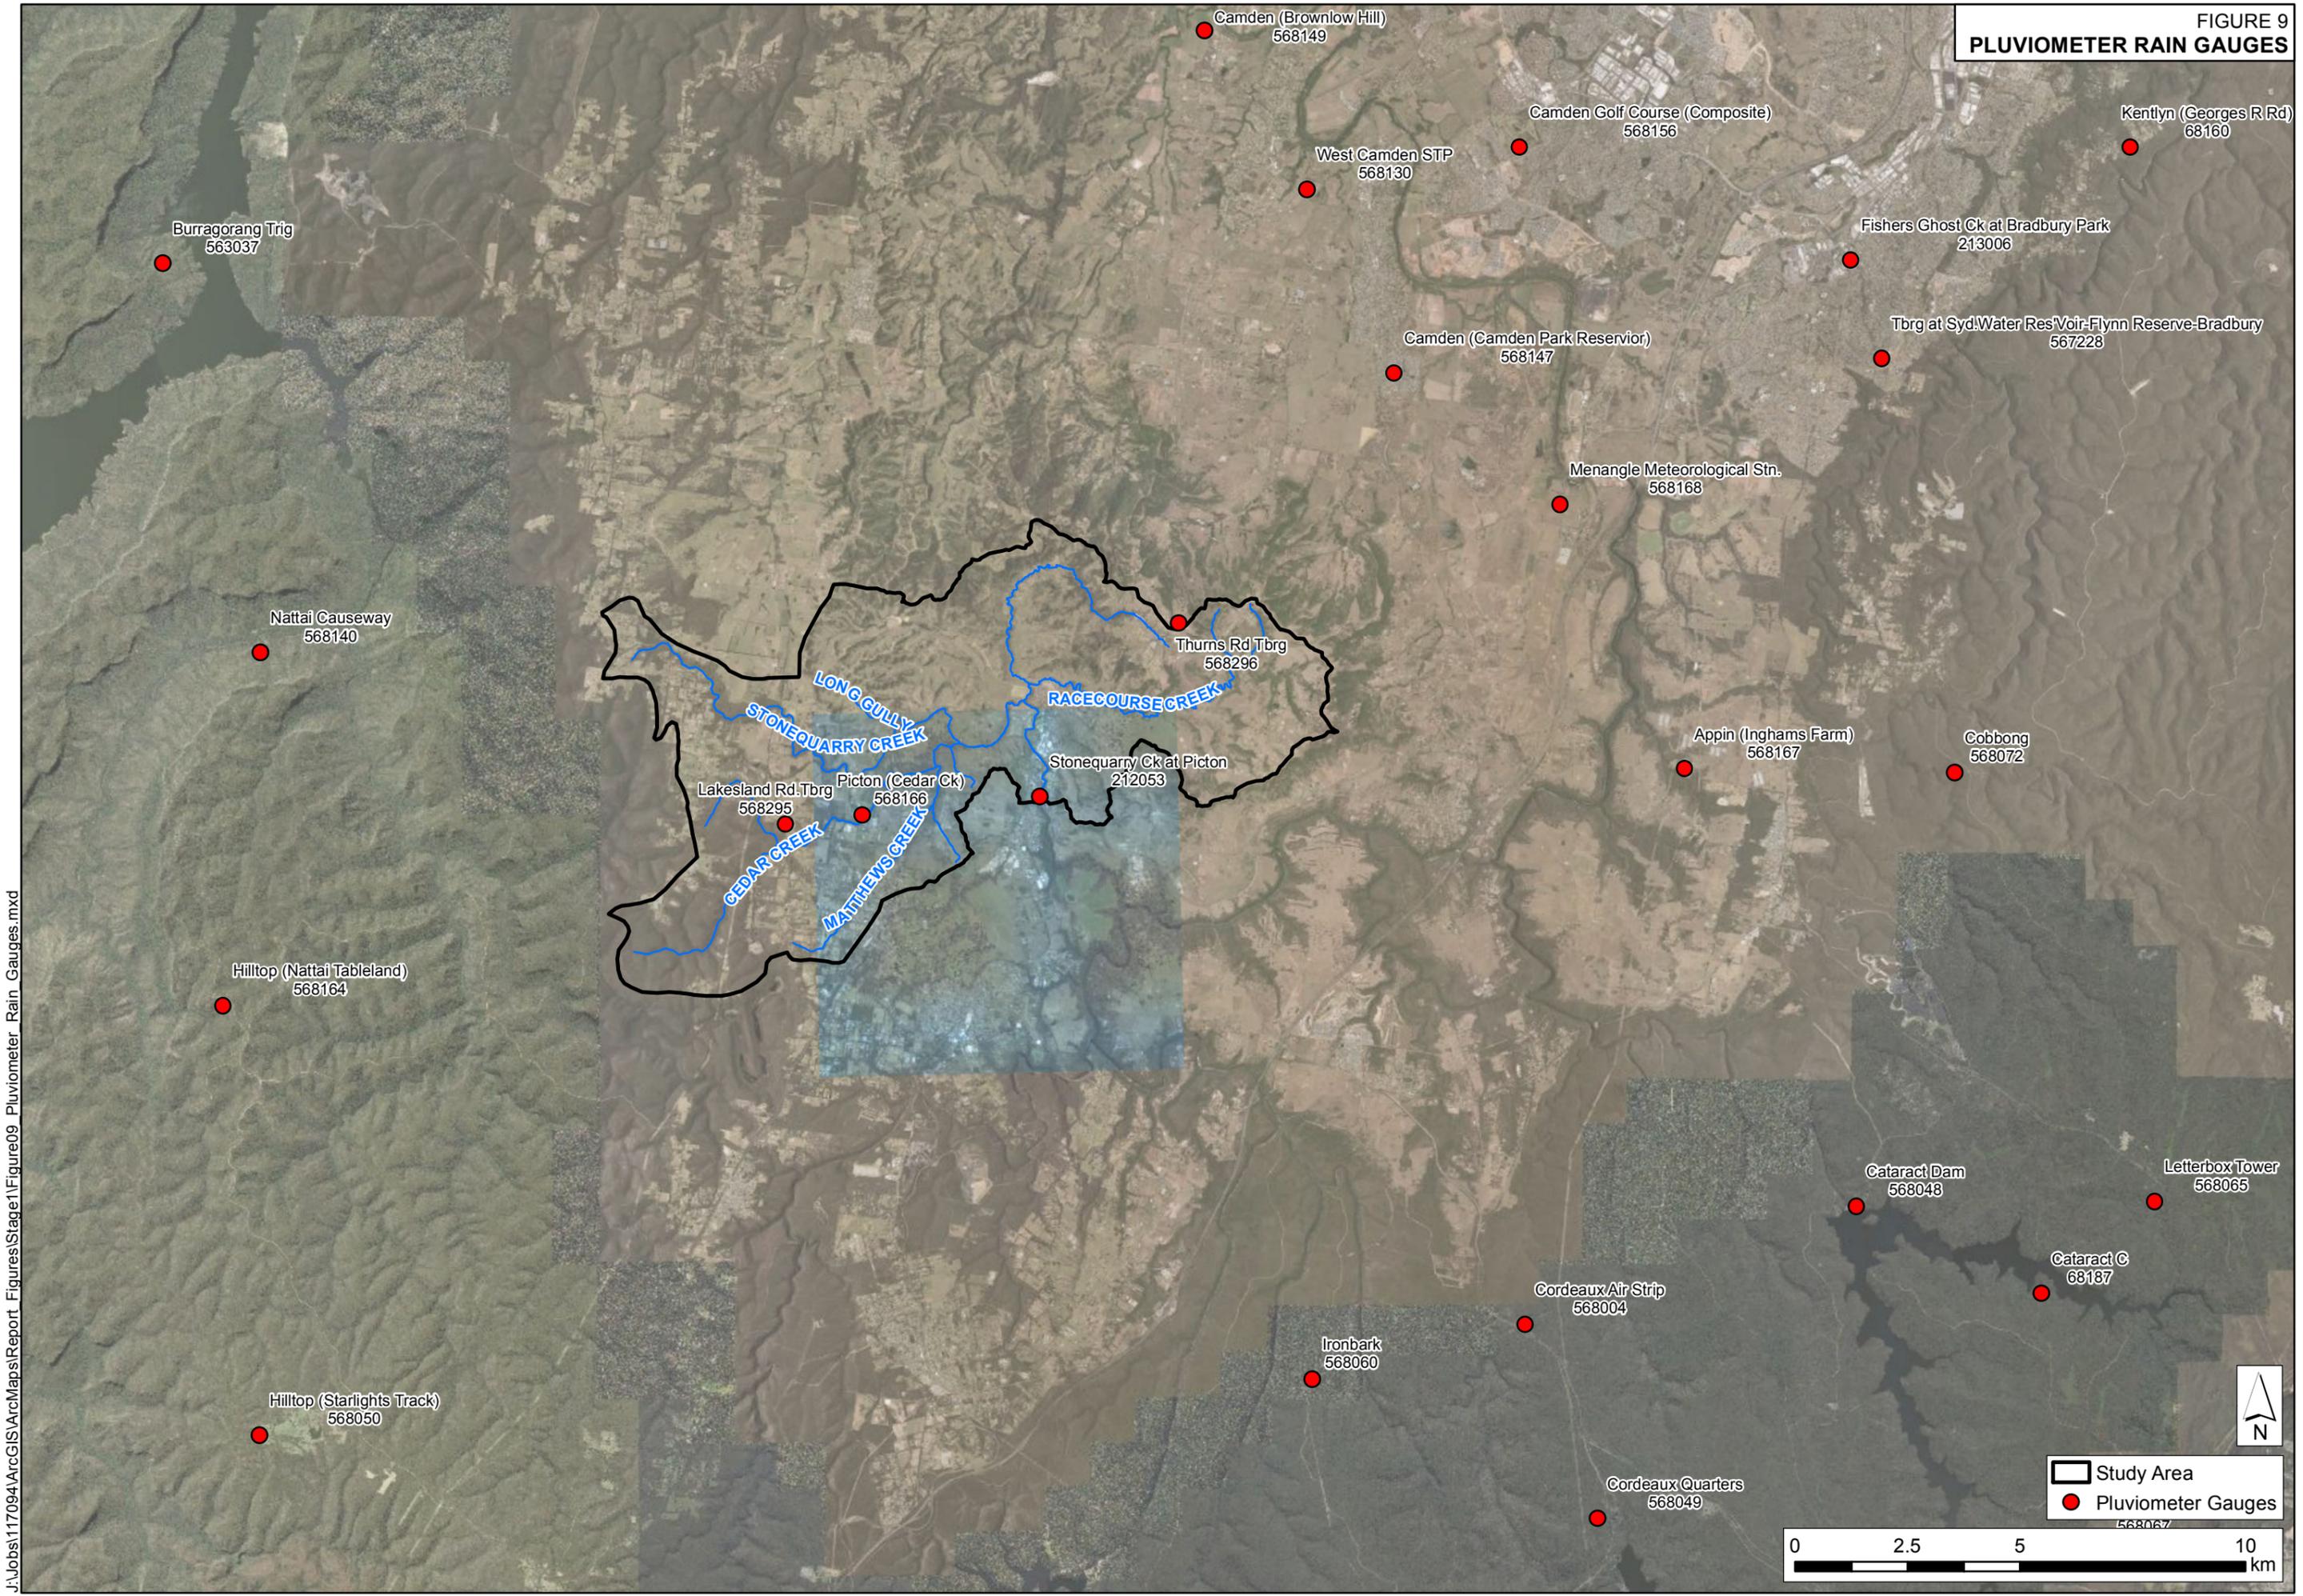
FIGURE 9
PLUVIOMETER RAIN GAUGES

Study Area
Pluviometer Gauges

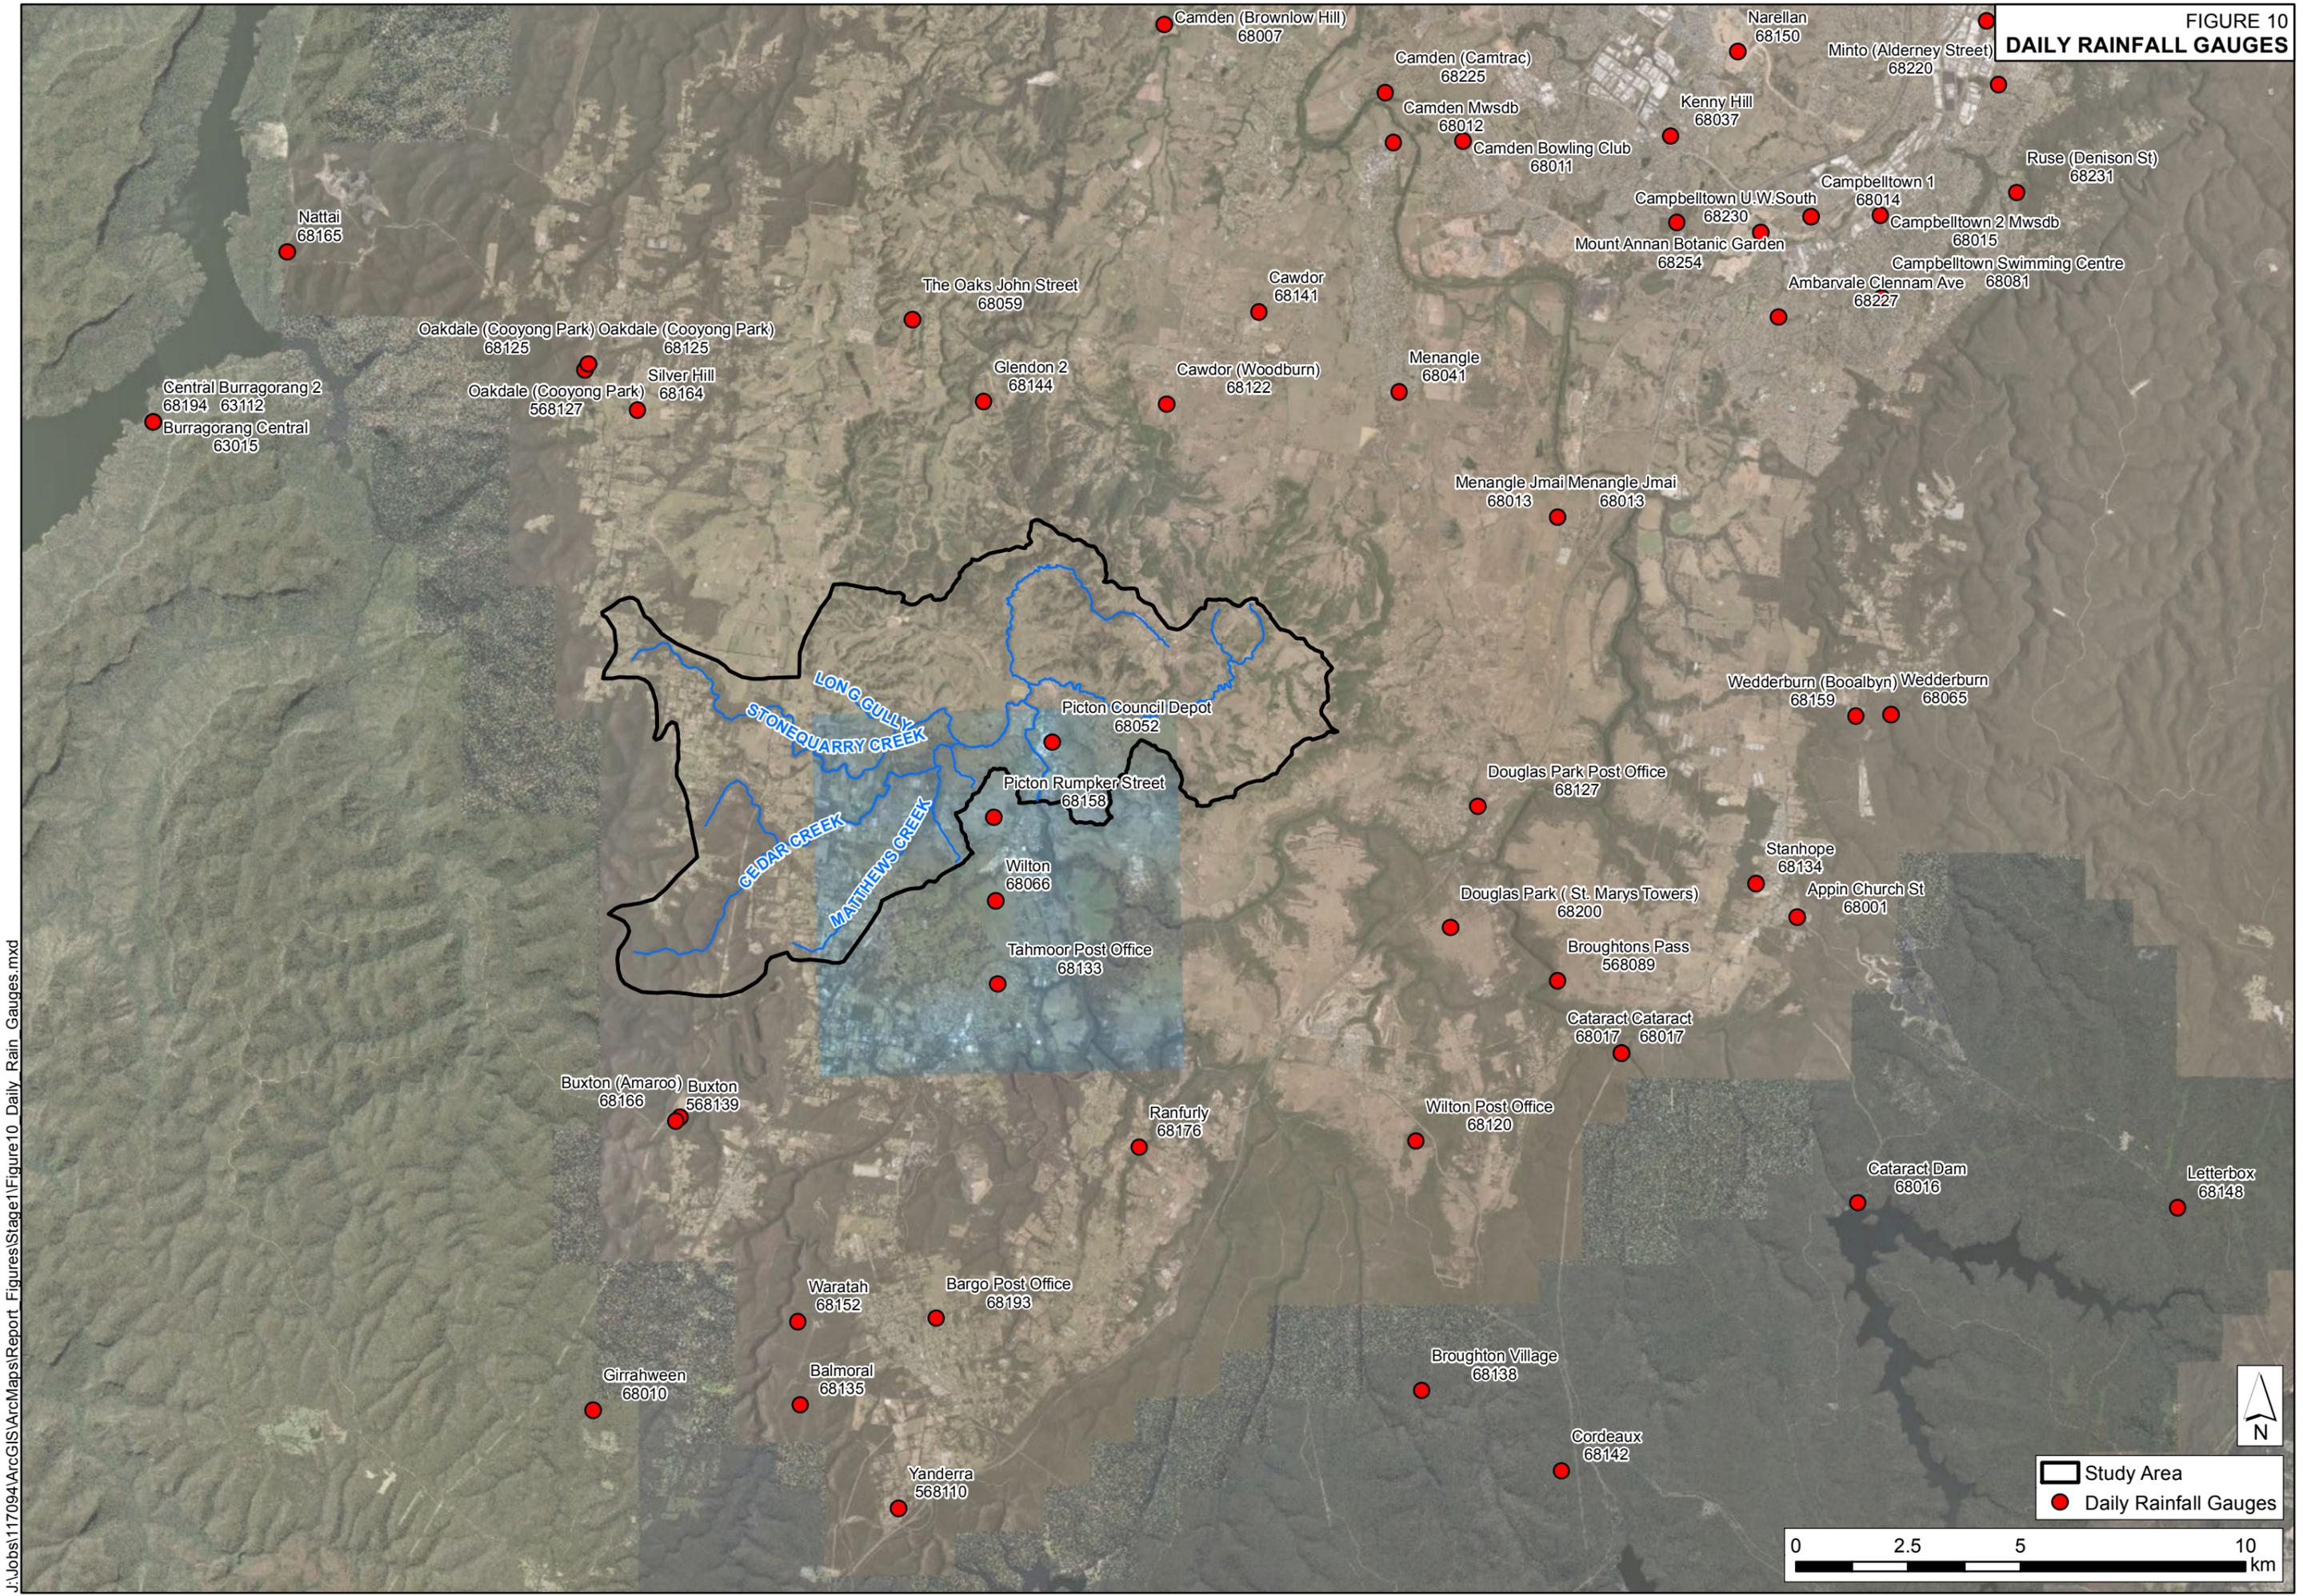
DAILY RAINFALL GAUGES

Study Area
● Daily Rainfall Gauges

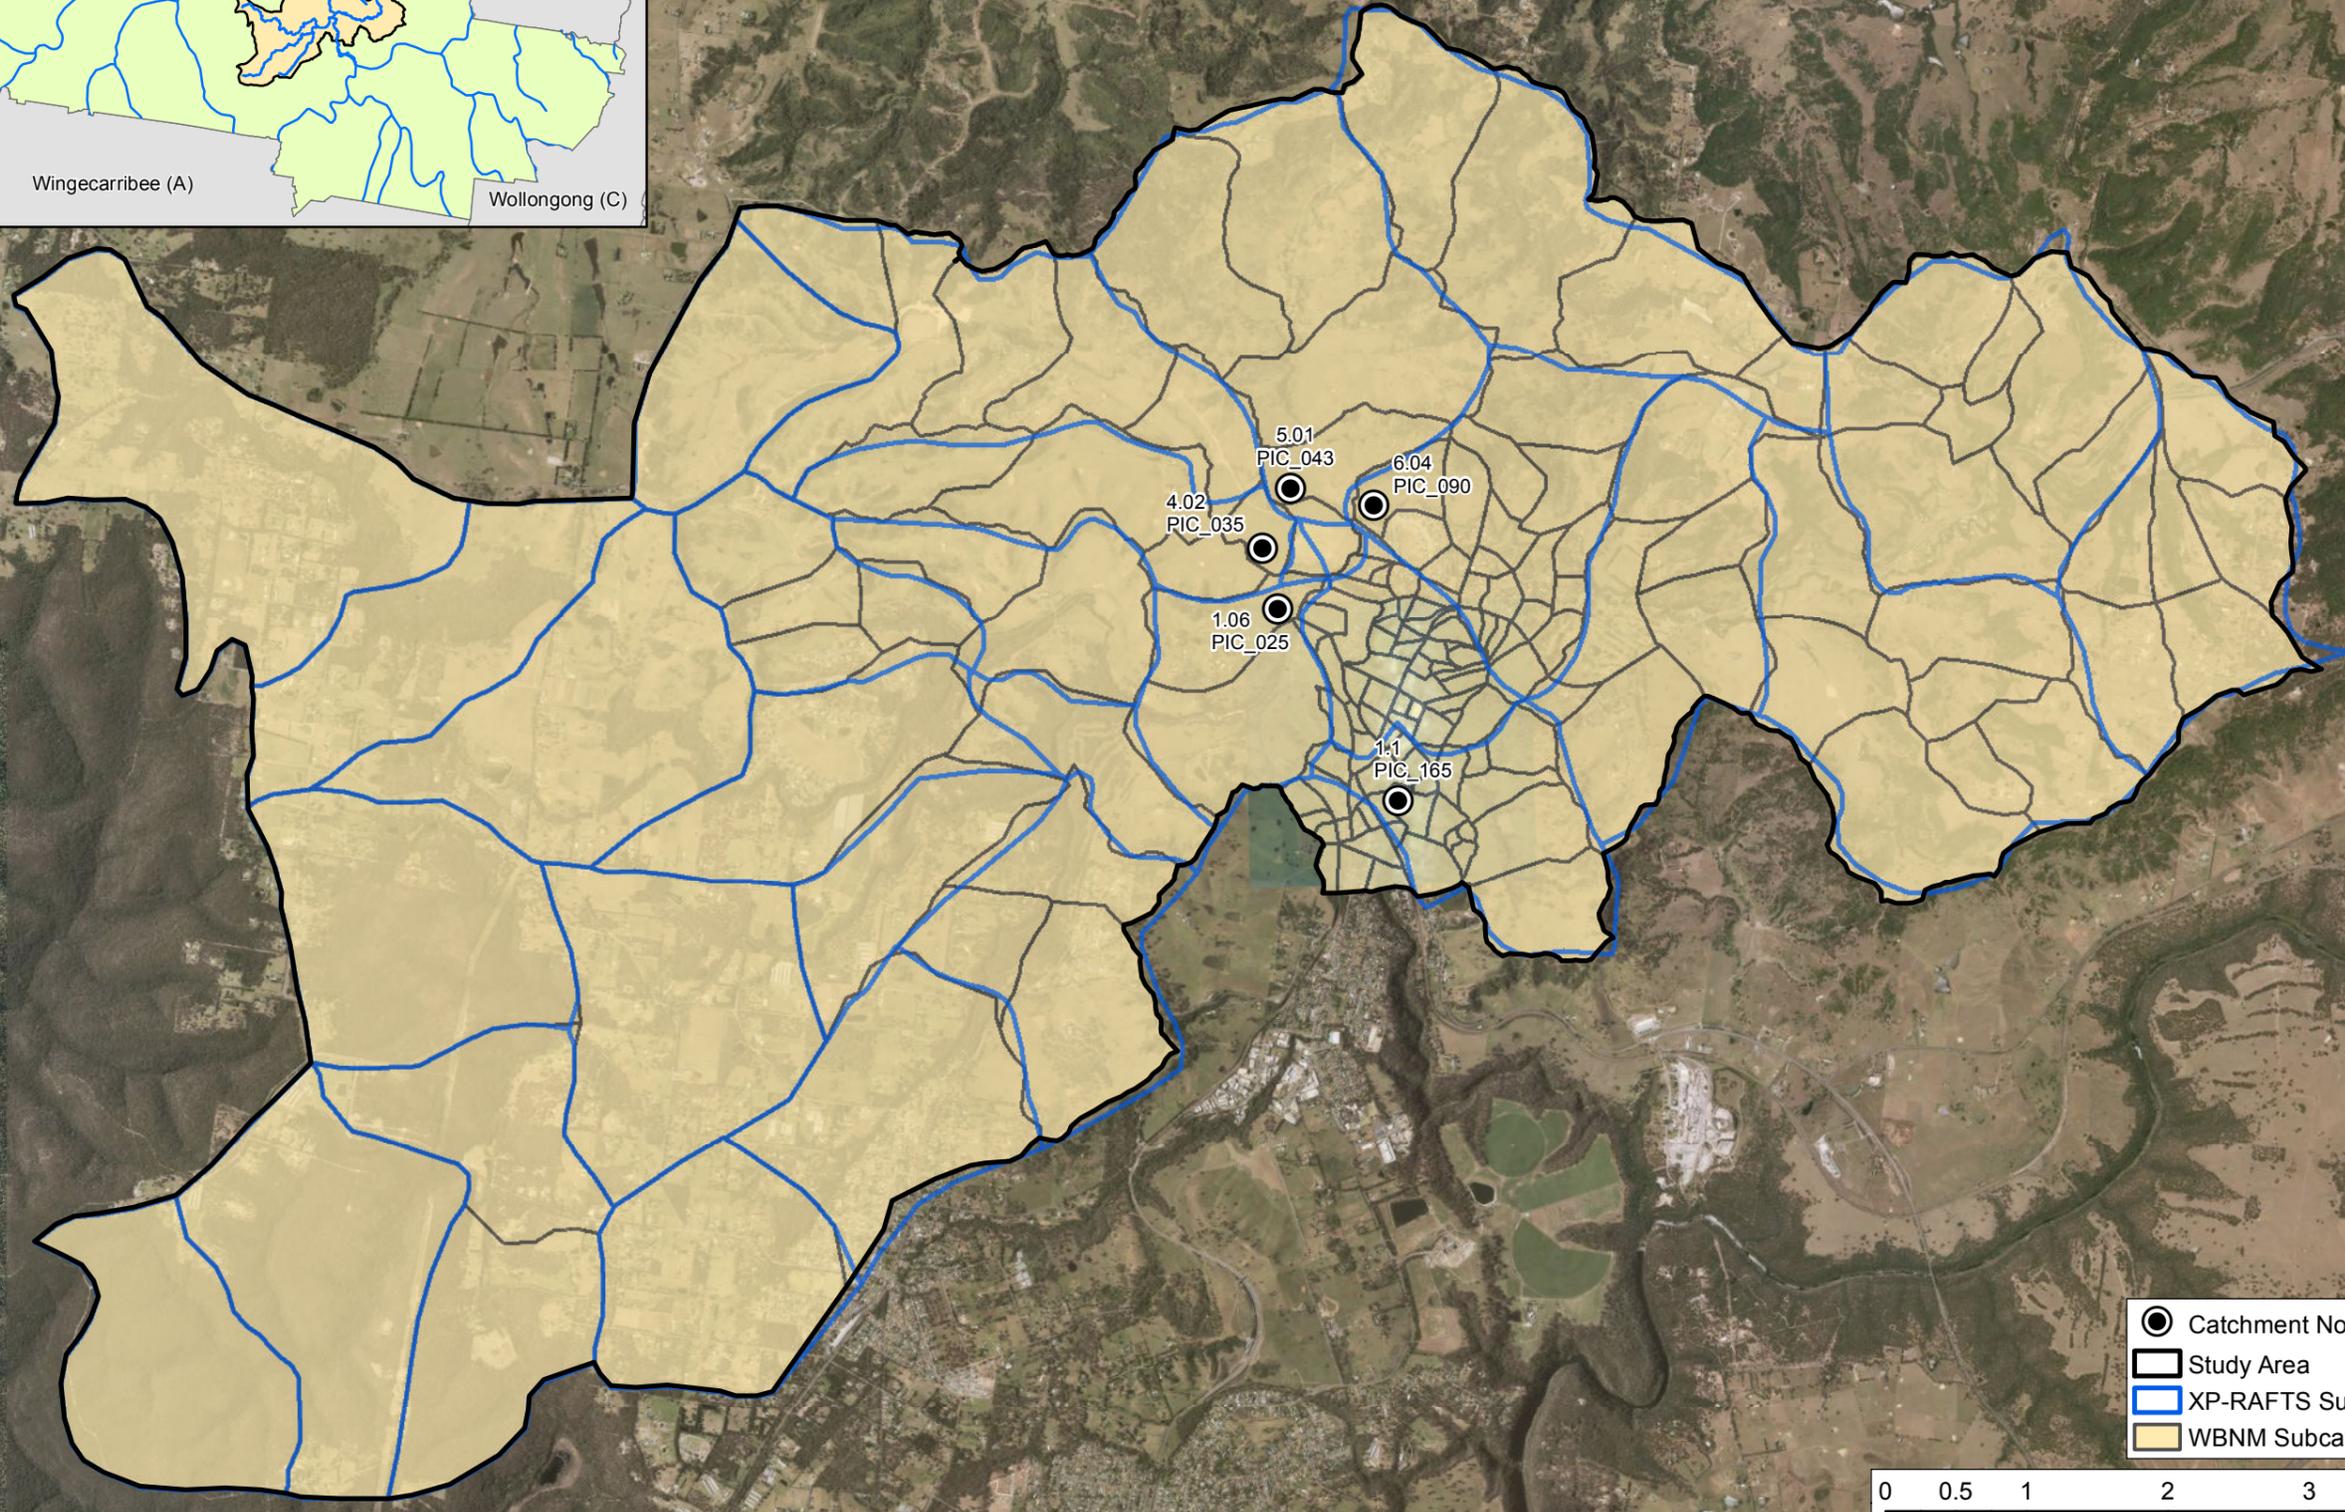
FIGURE 11
WBNM HYDROLOGIC MODEL
SUBCATCHMENT DELINEATION

- Catchment Node
- ▭ Study Area
- ▬ XP-RAFTS Subcatchments
- ▭ WBNM Subcatchments

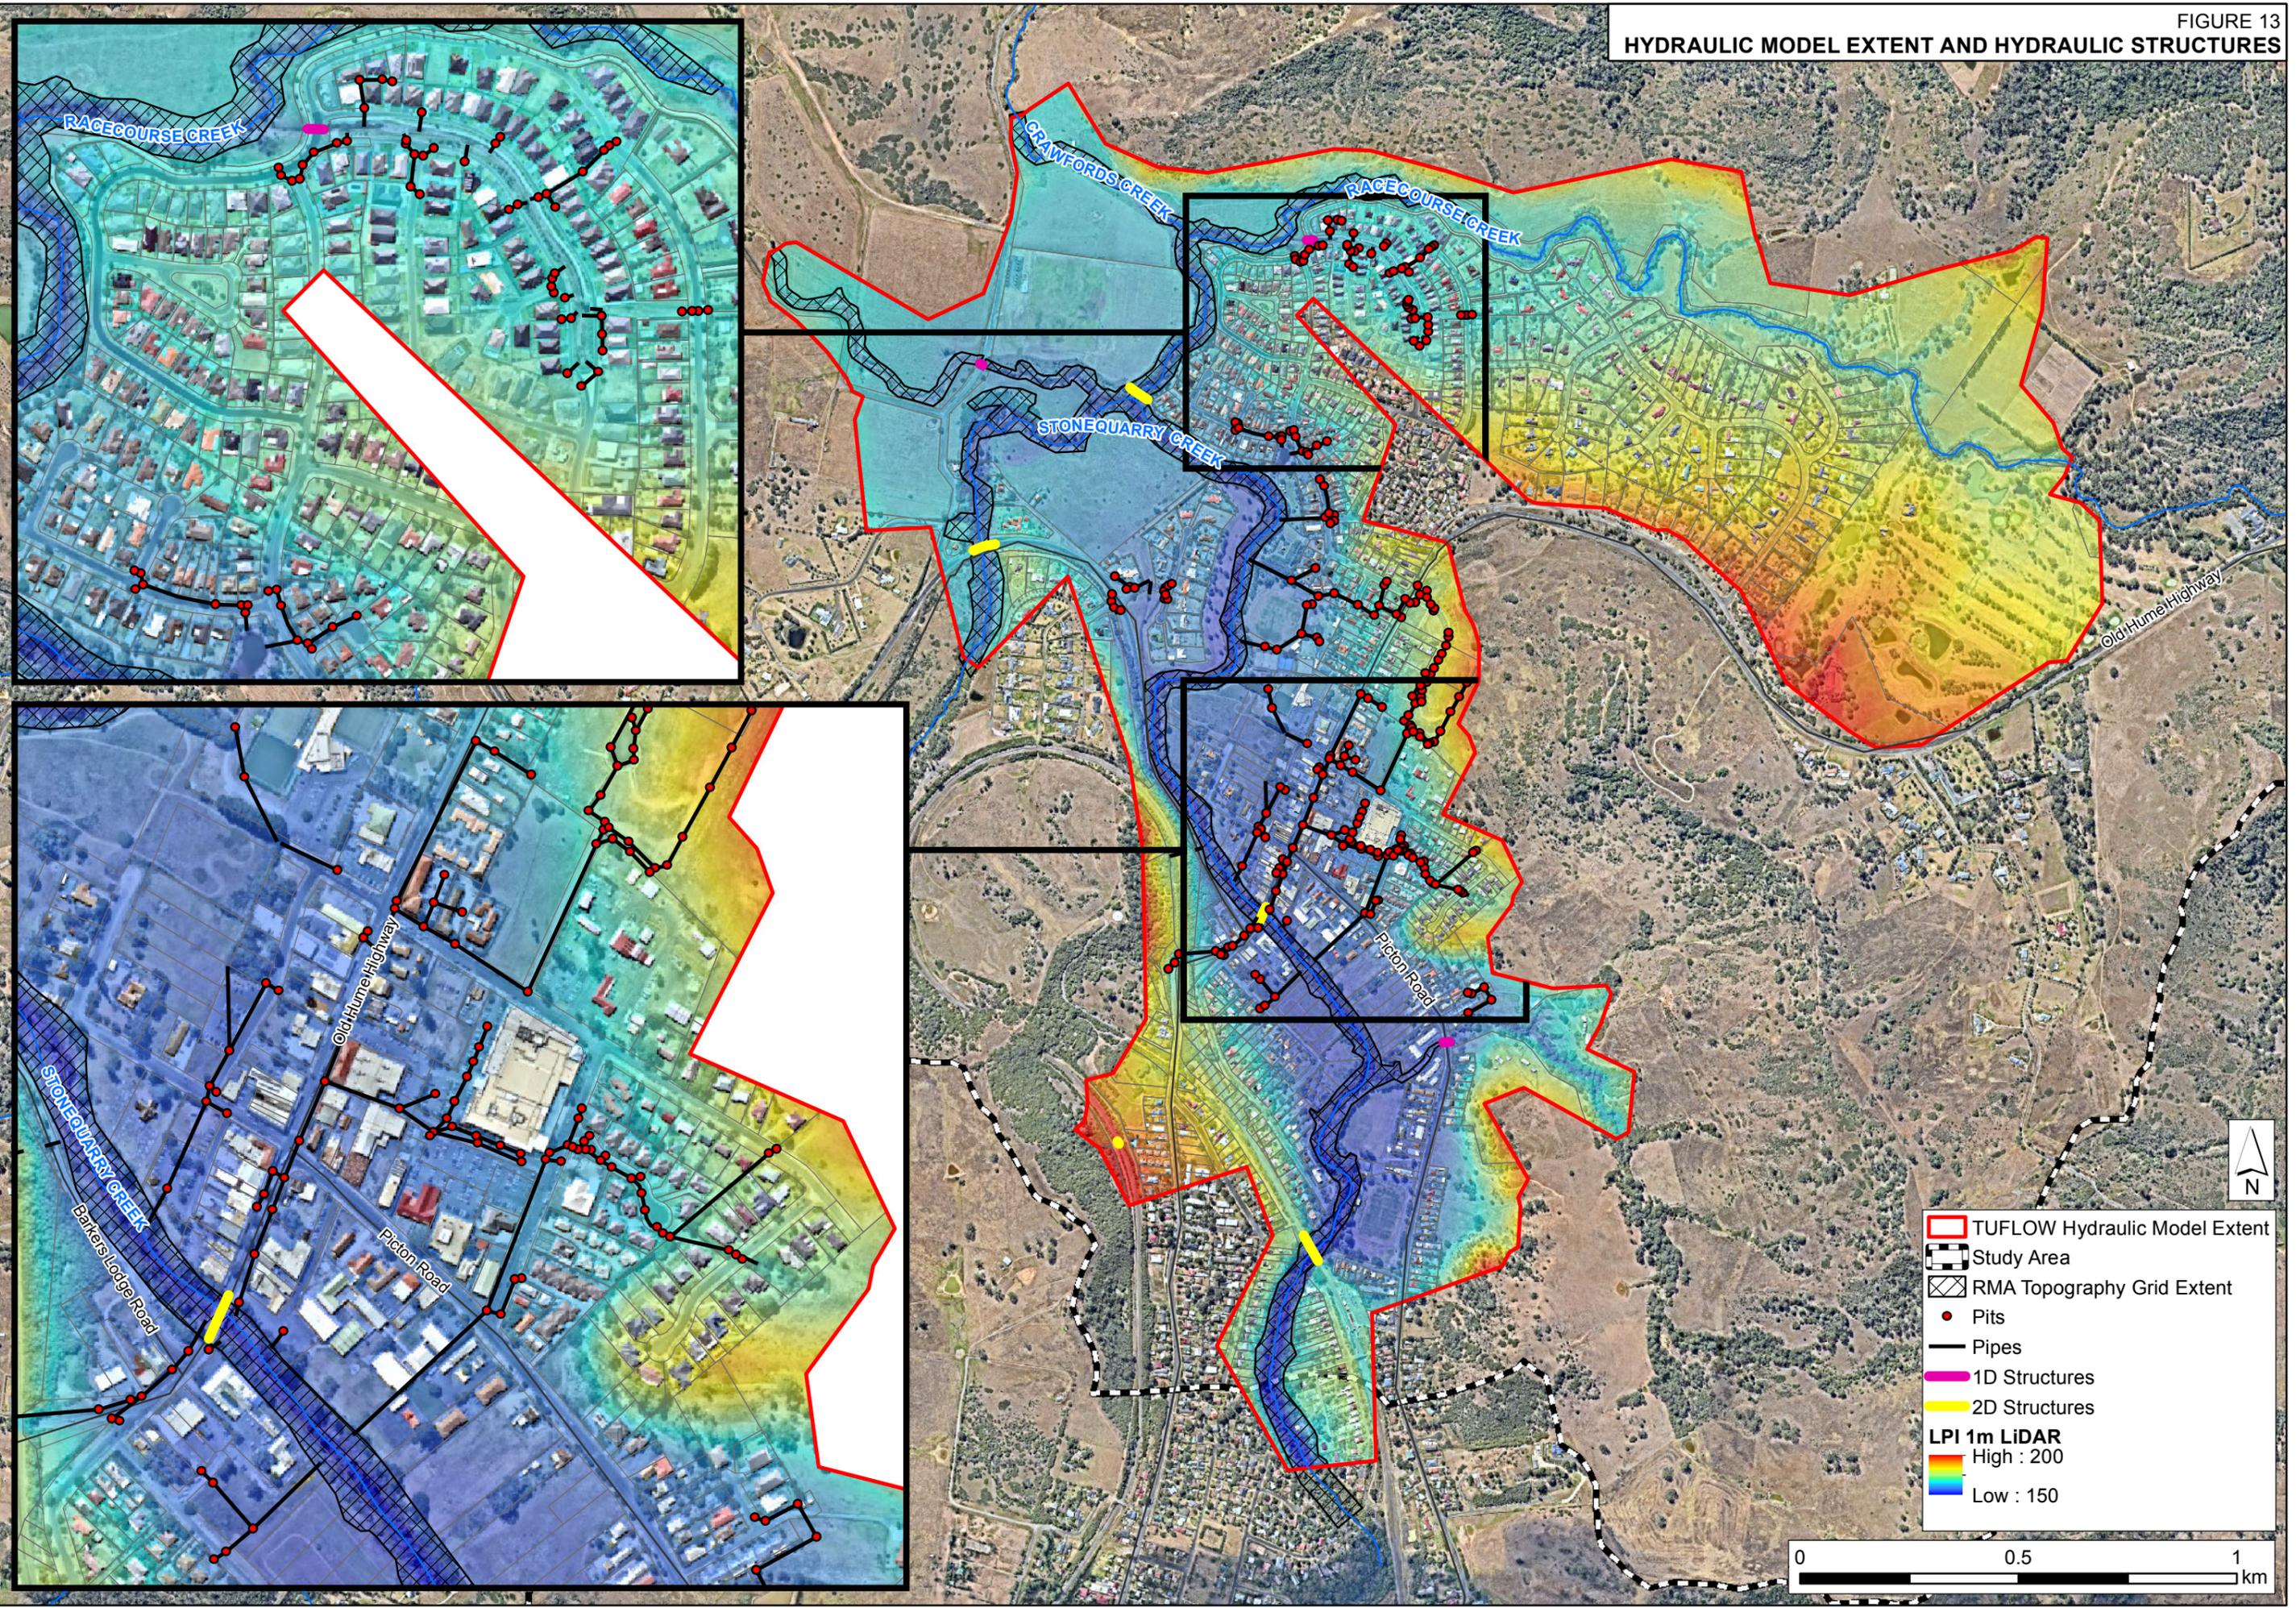
HYDRAULIC MODEL EXTENT AND HYDRAULIC STRUCTURES

TUFLOW Hydraulic Model Extent
-

Pits
-

Pipes
-

1D Structures
-

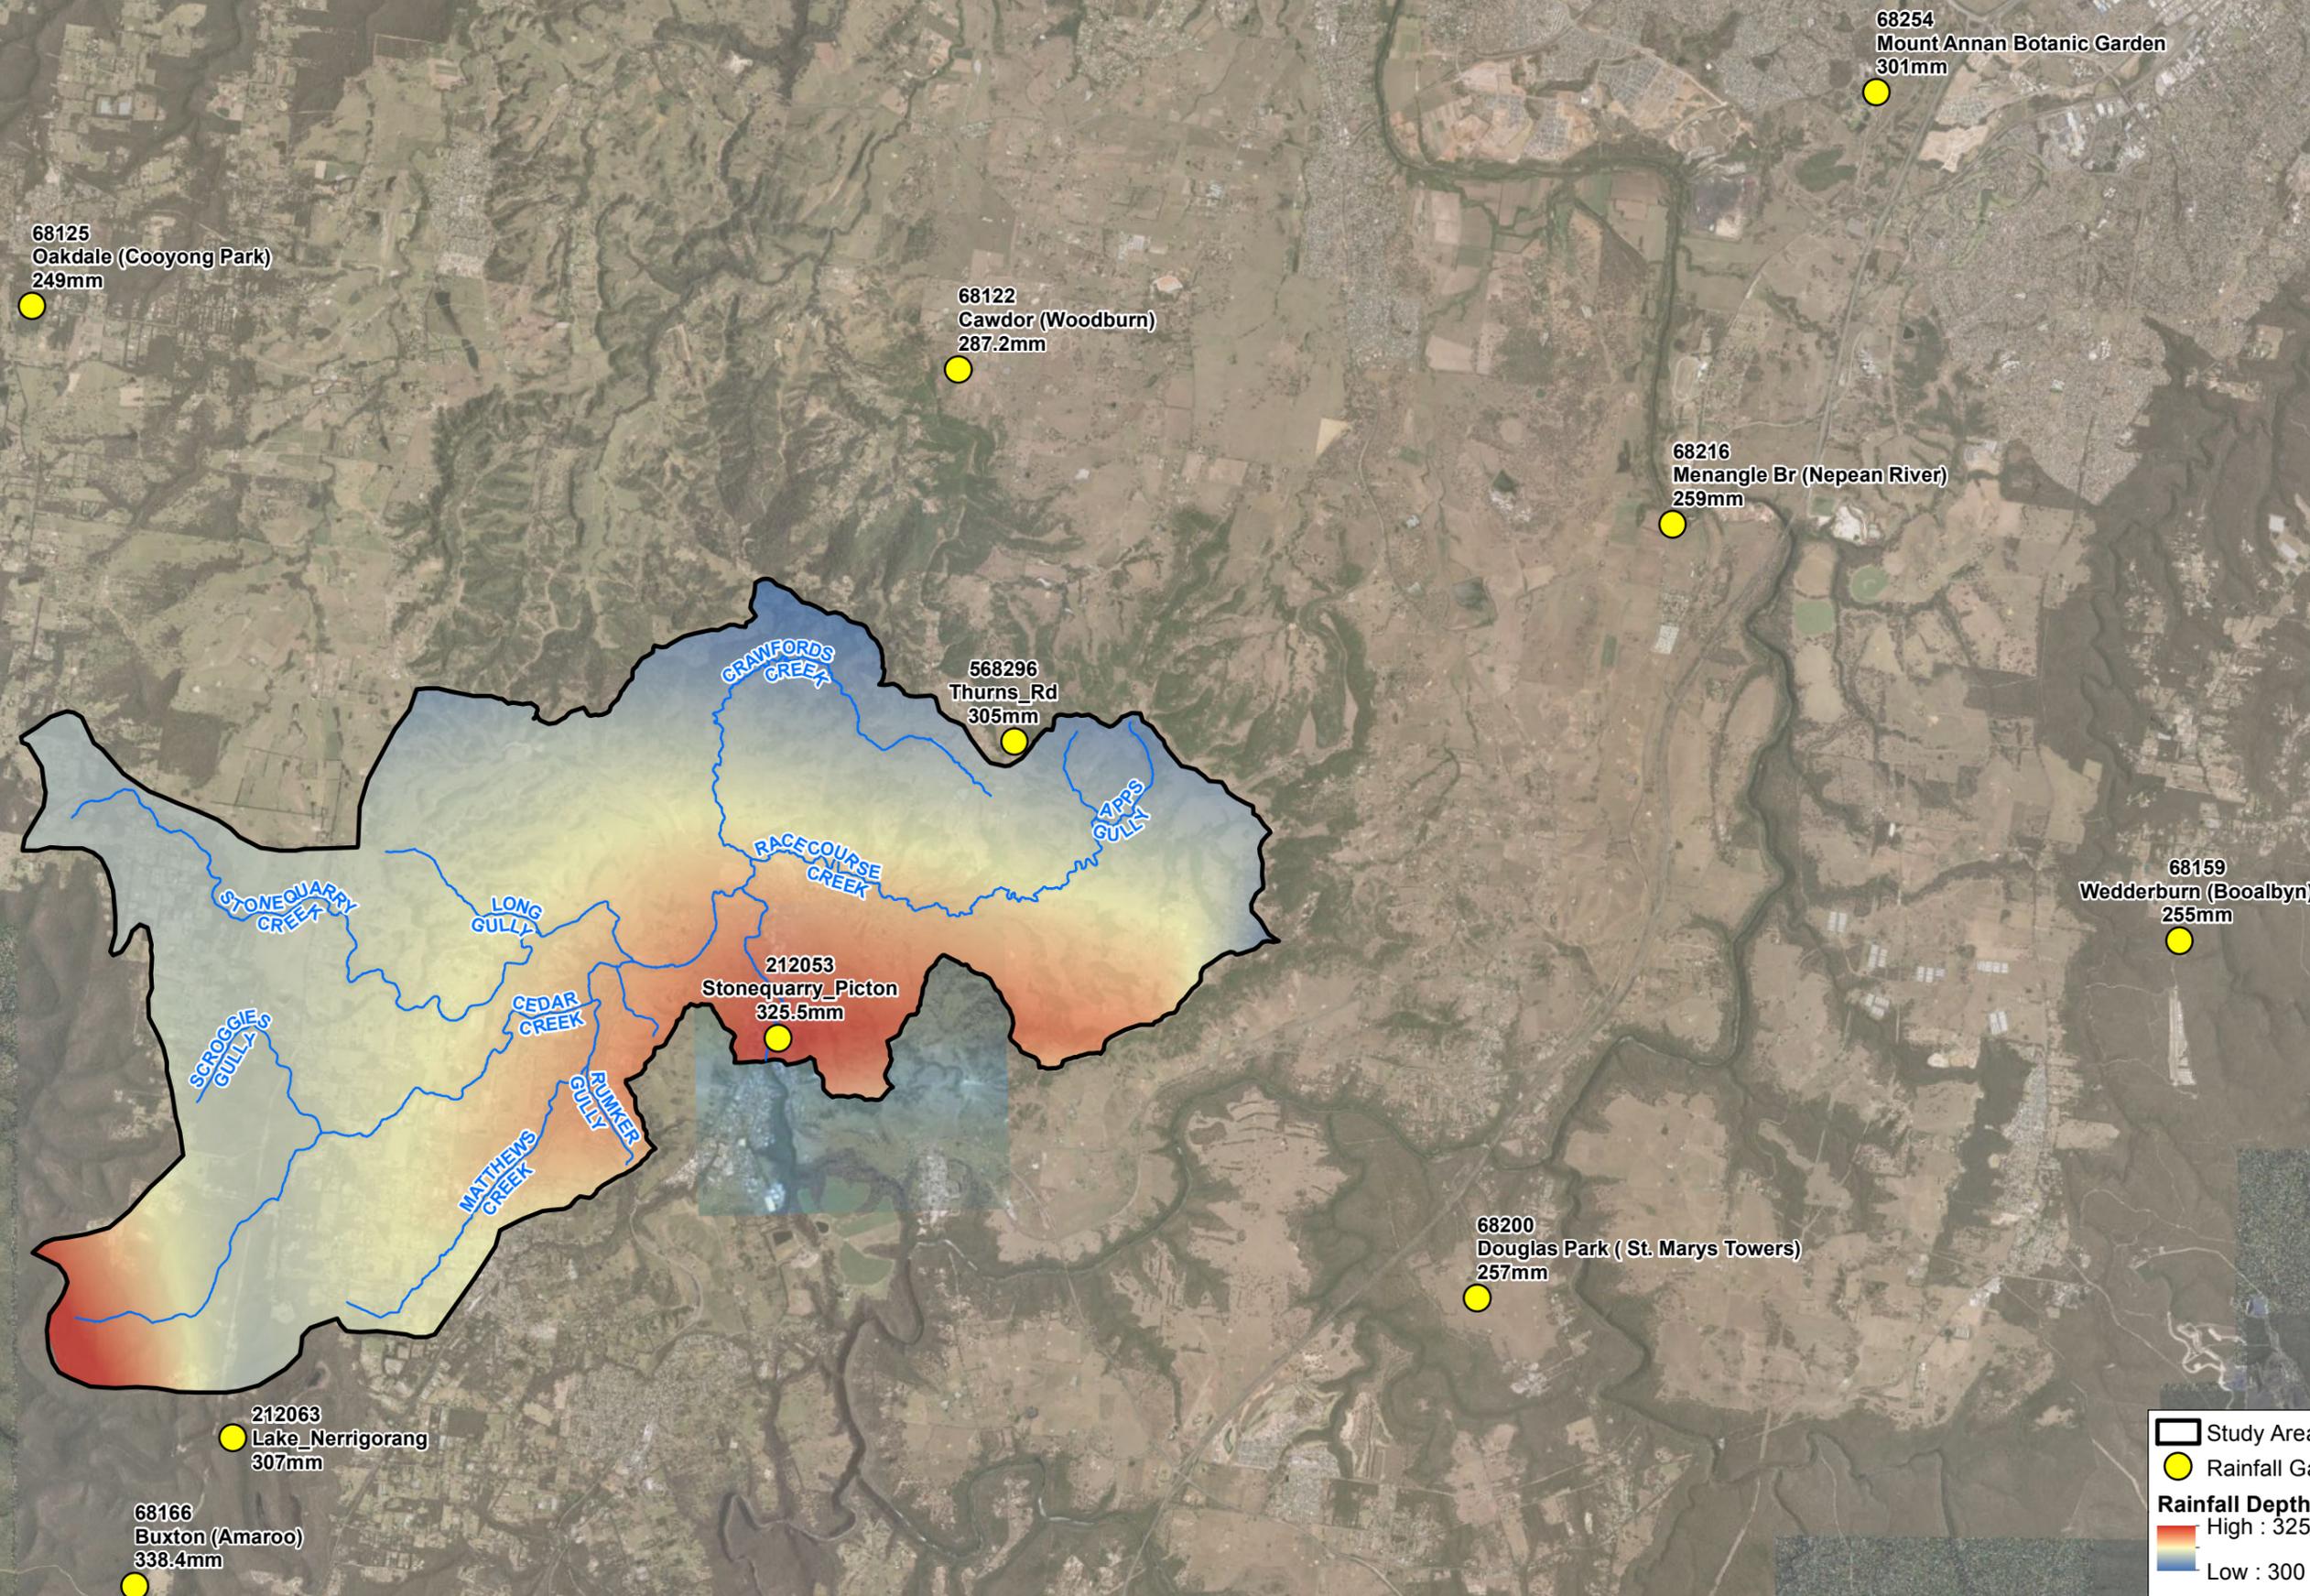
FIGURE 15
 JUNE 2016 CALIBRATION EVENT
 RAINFALL DATA

Study Area
● Rainfall Gauges
Rainfall Depth (mm)
 High : 325
 Low : 300
