STONEQUARRY CREEK (PICTON) FLOOD STUDY UPDATE FINAL VOLUME II

FIGURES

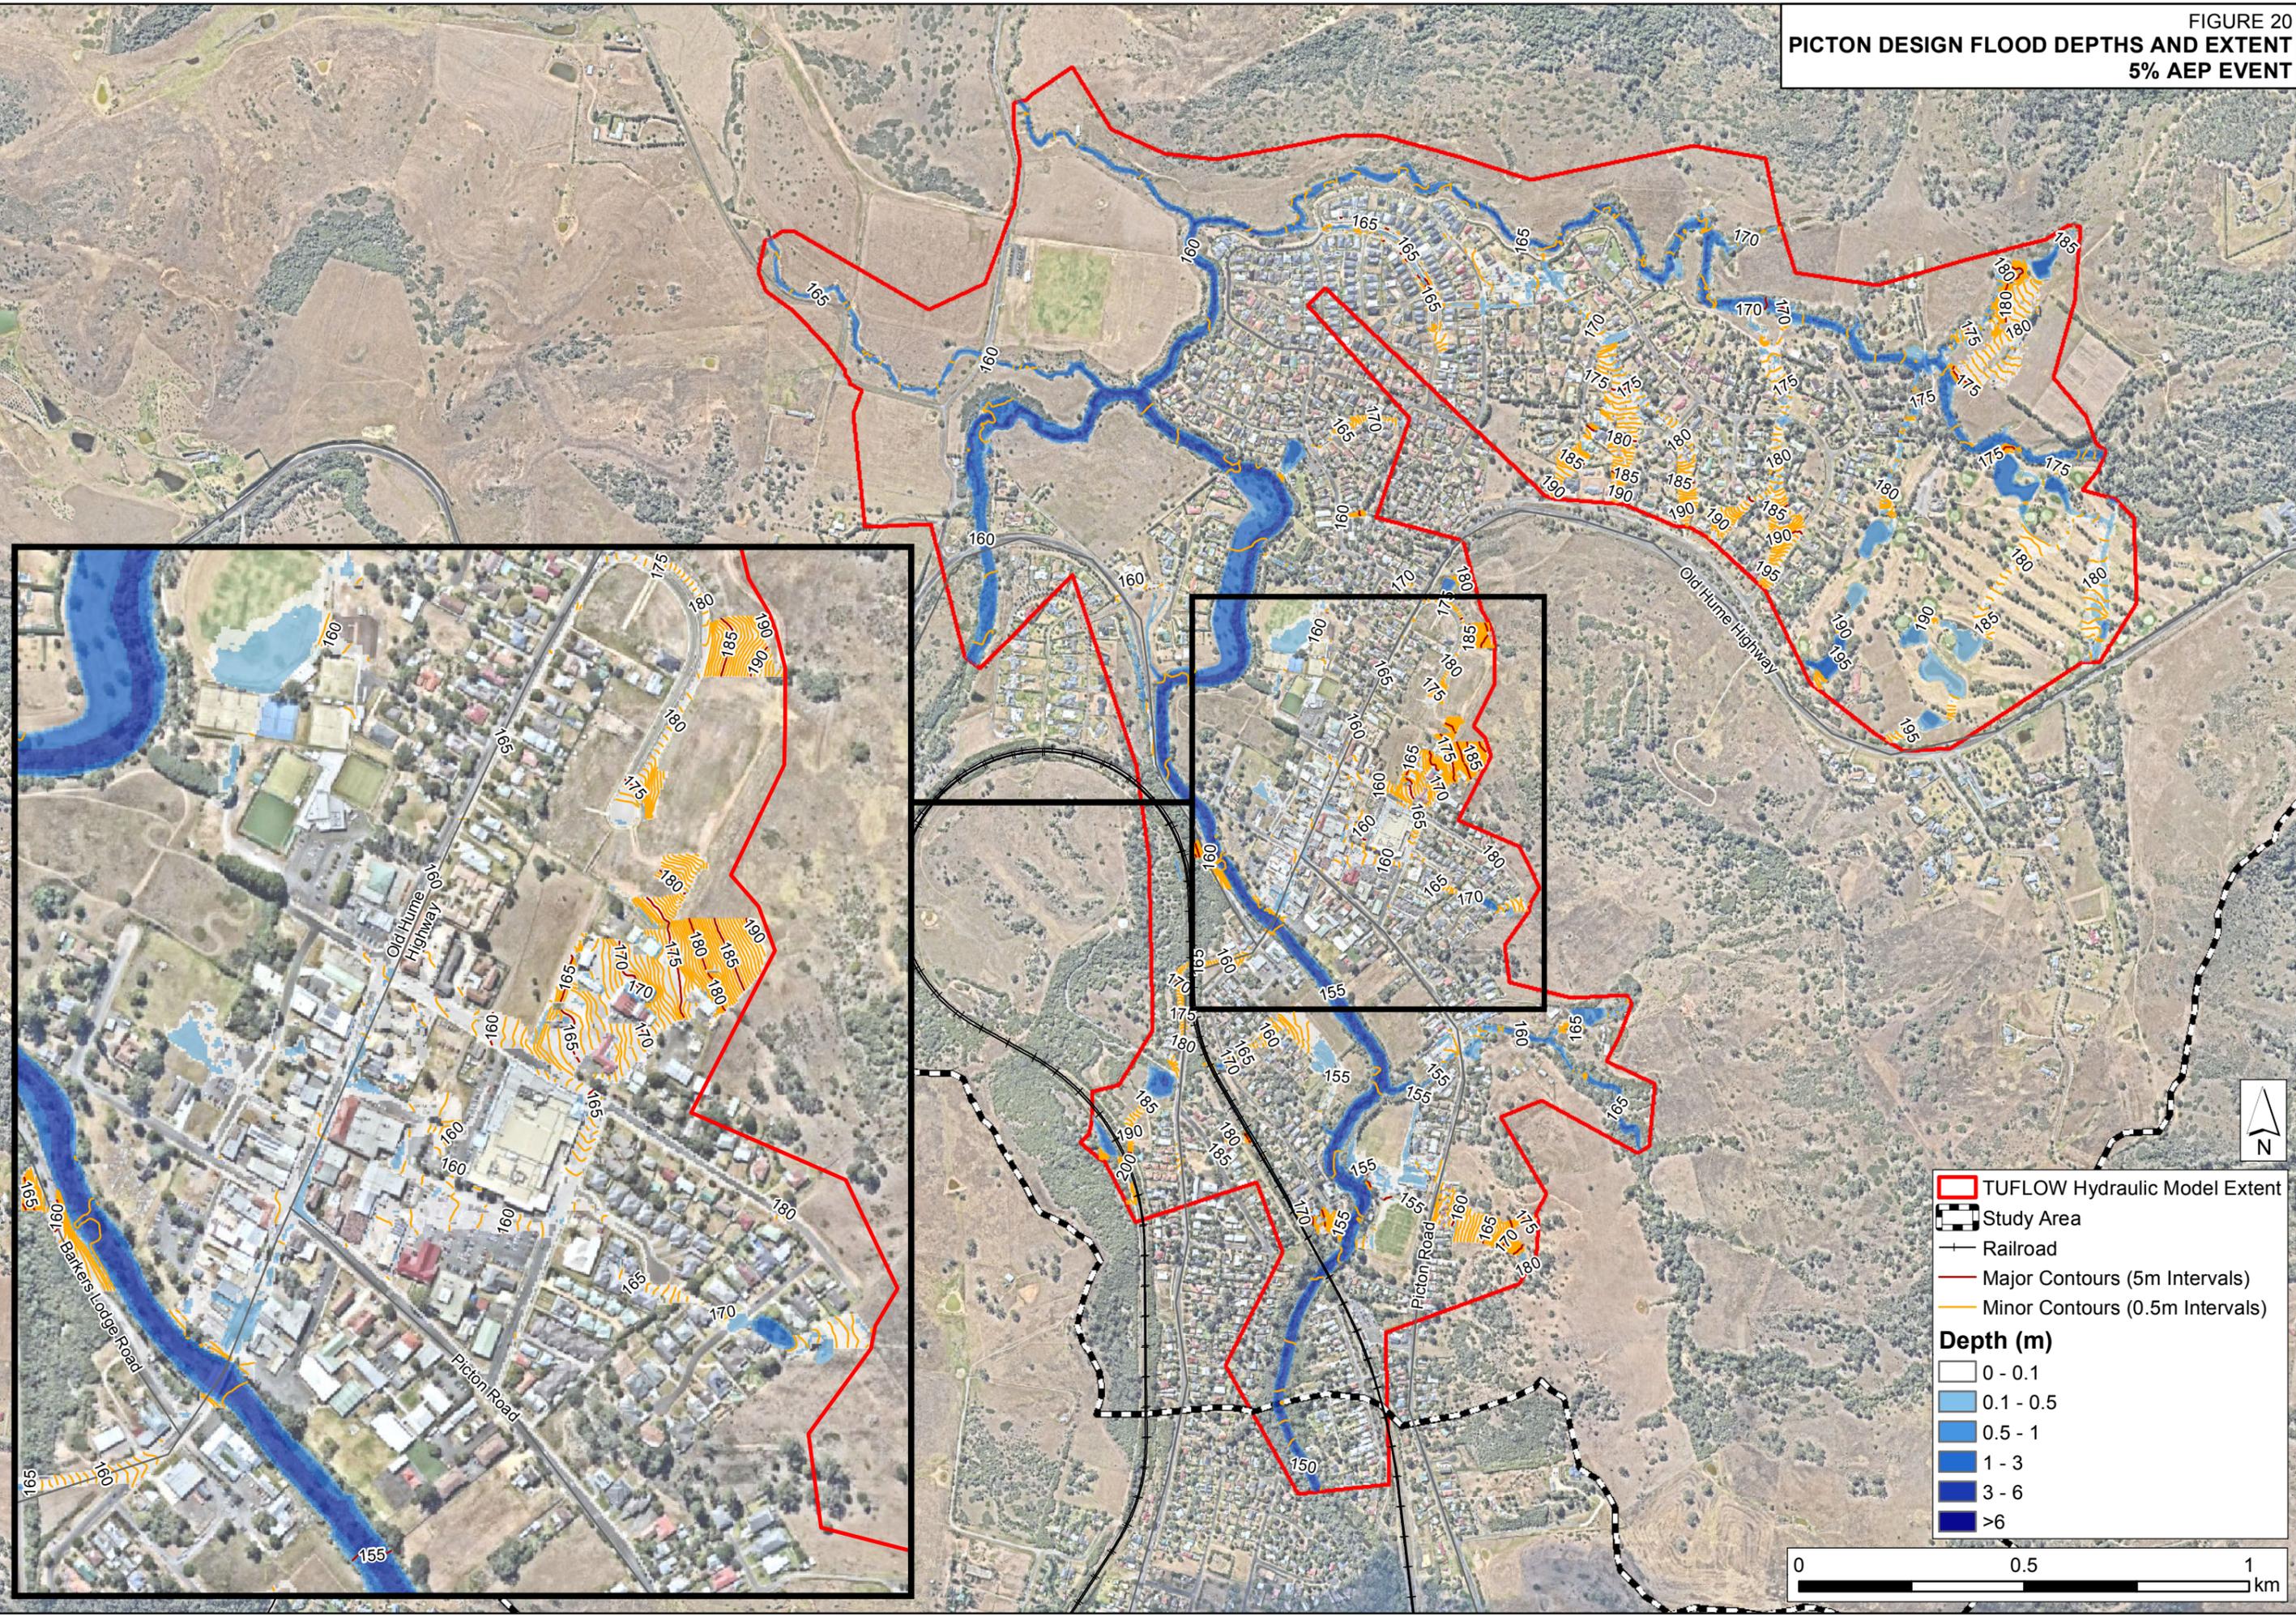
FIGURE 20
PICTON DESIGN FLOOD DEPTHS AND EXTENT
5% AEP EVENT

- TUFLOW Hydraulic Model Extent
- Study Area
- Railroad
- Major Contours (5m Intervals)
- Minor Contours (0.5m Intervals)

- 0 - 0.1
- 0.1 - 0.5
- 0.5 - 1
- 1 - 3
- 3 - 6
- >6

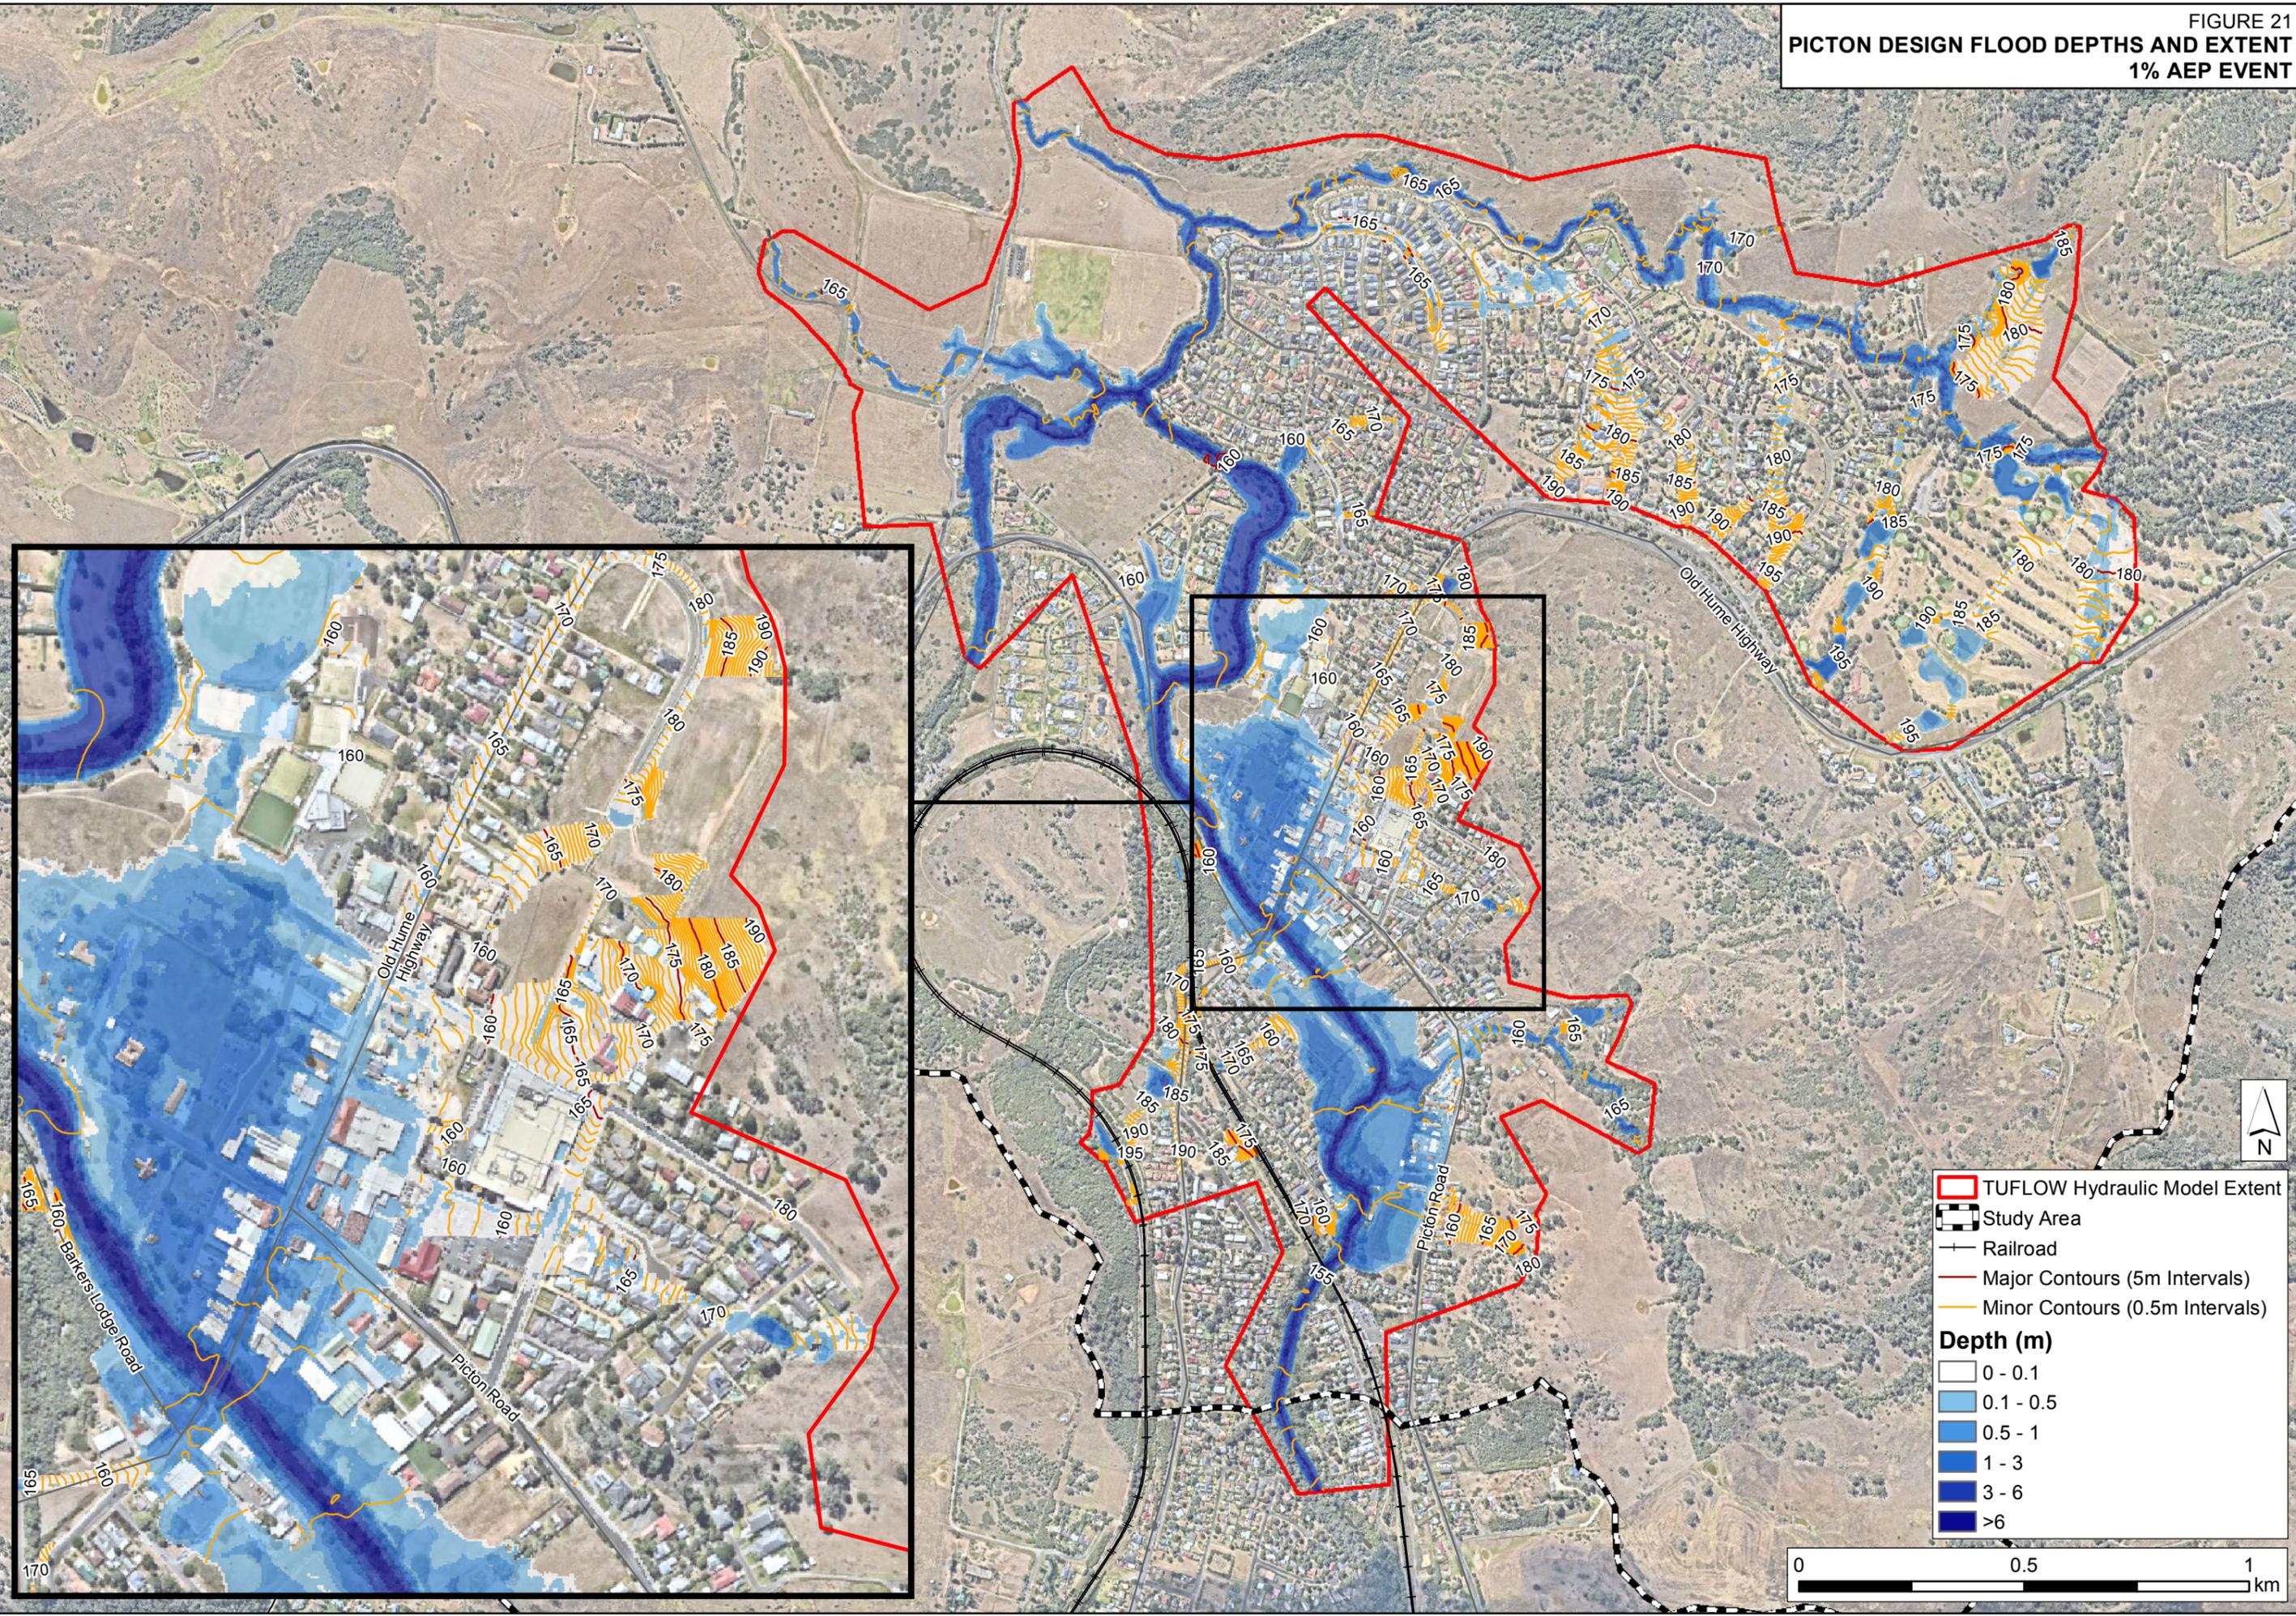
FIGURE 21
PICTON DESIGN FLOOD DEPTHS AND EXTENT
1% AEP EVENT

- TUFLOW Hydraulic Model Extent
- Study Area
- Railroad
- Major Contours (5m Intervals)
- Minor Contours (0.5m Intervals)

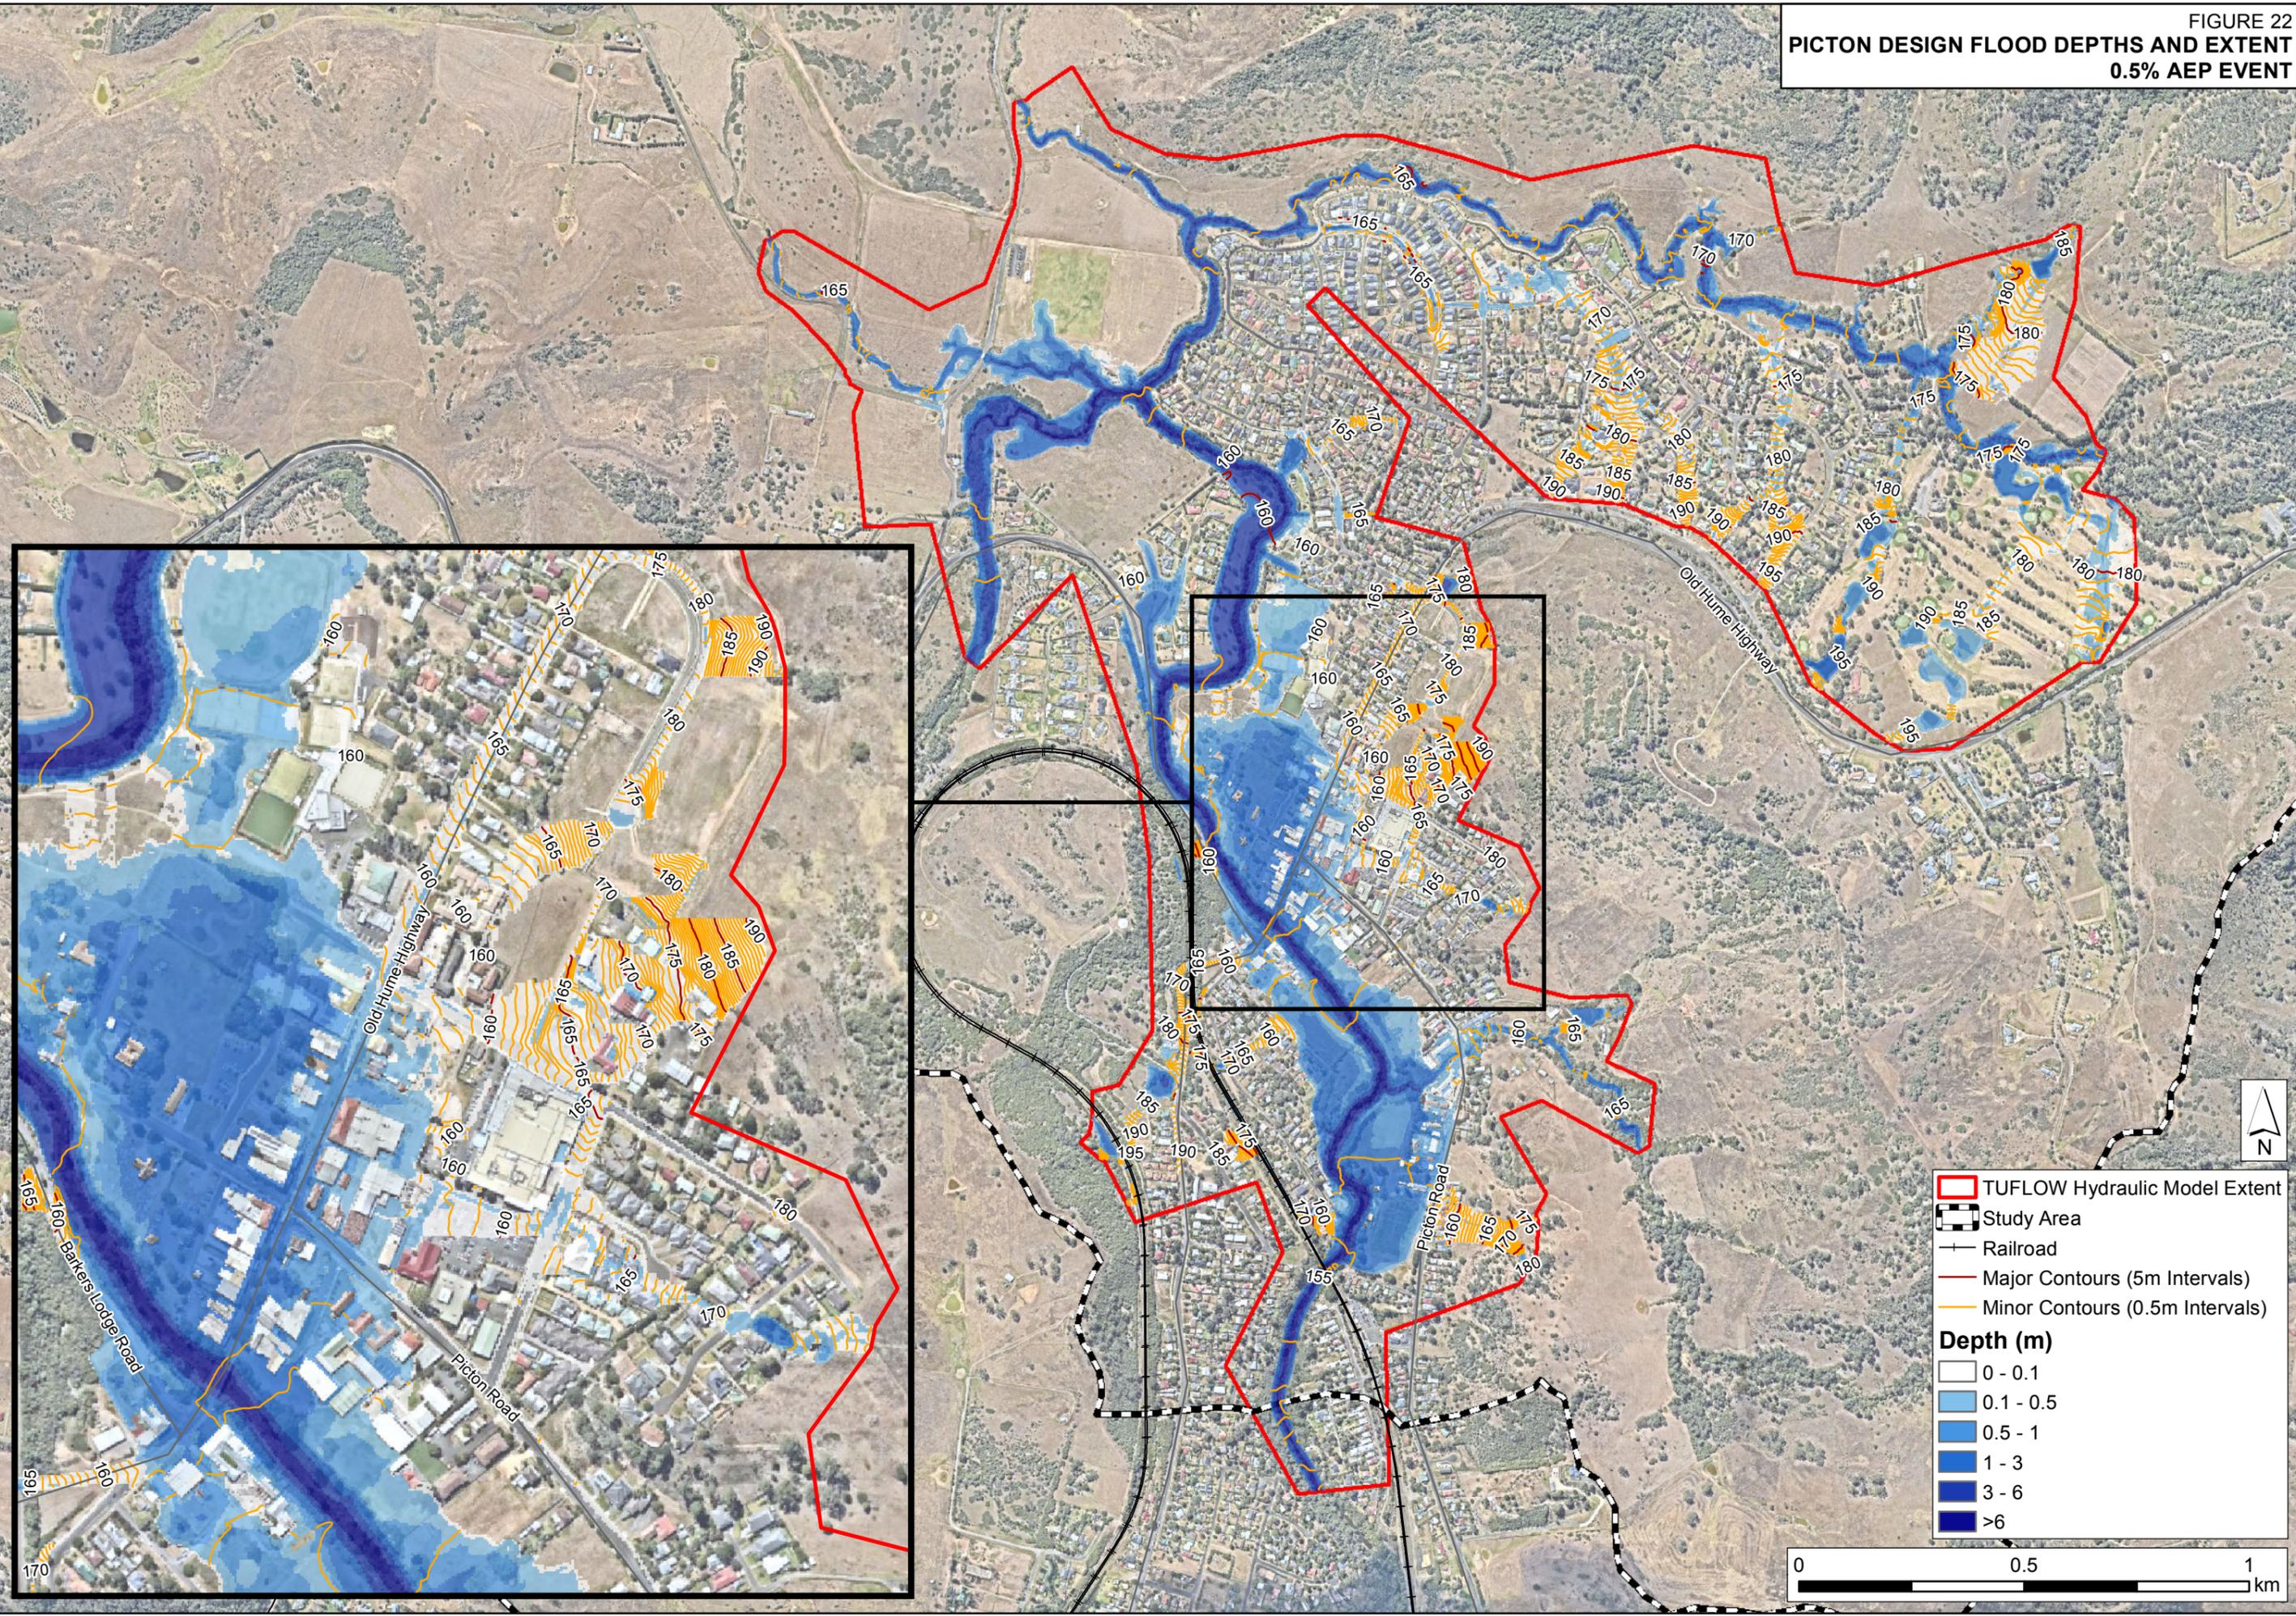
FIGURE 22
PICTON DESIGN FLOOD DEPTHS AND EXTENT
0.5% AEP EVENT

- TUFLOW Hydraulic Model Extent
- Study Area
- Railroad
- Major Contours (5m Intervals)
- Minor Contours (0.5m Intervals)

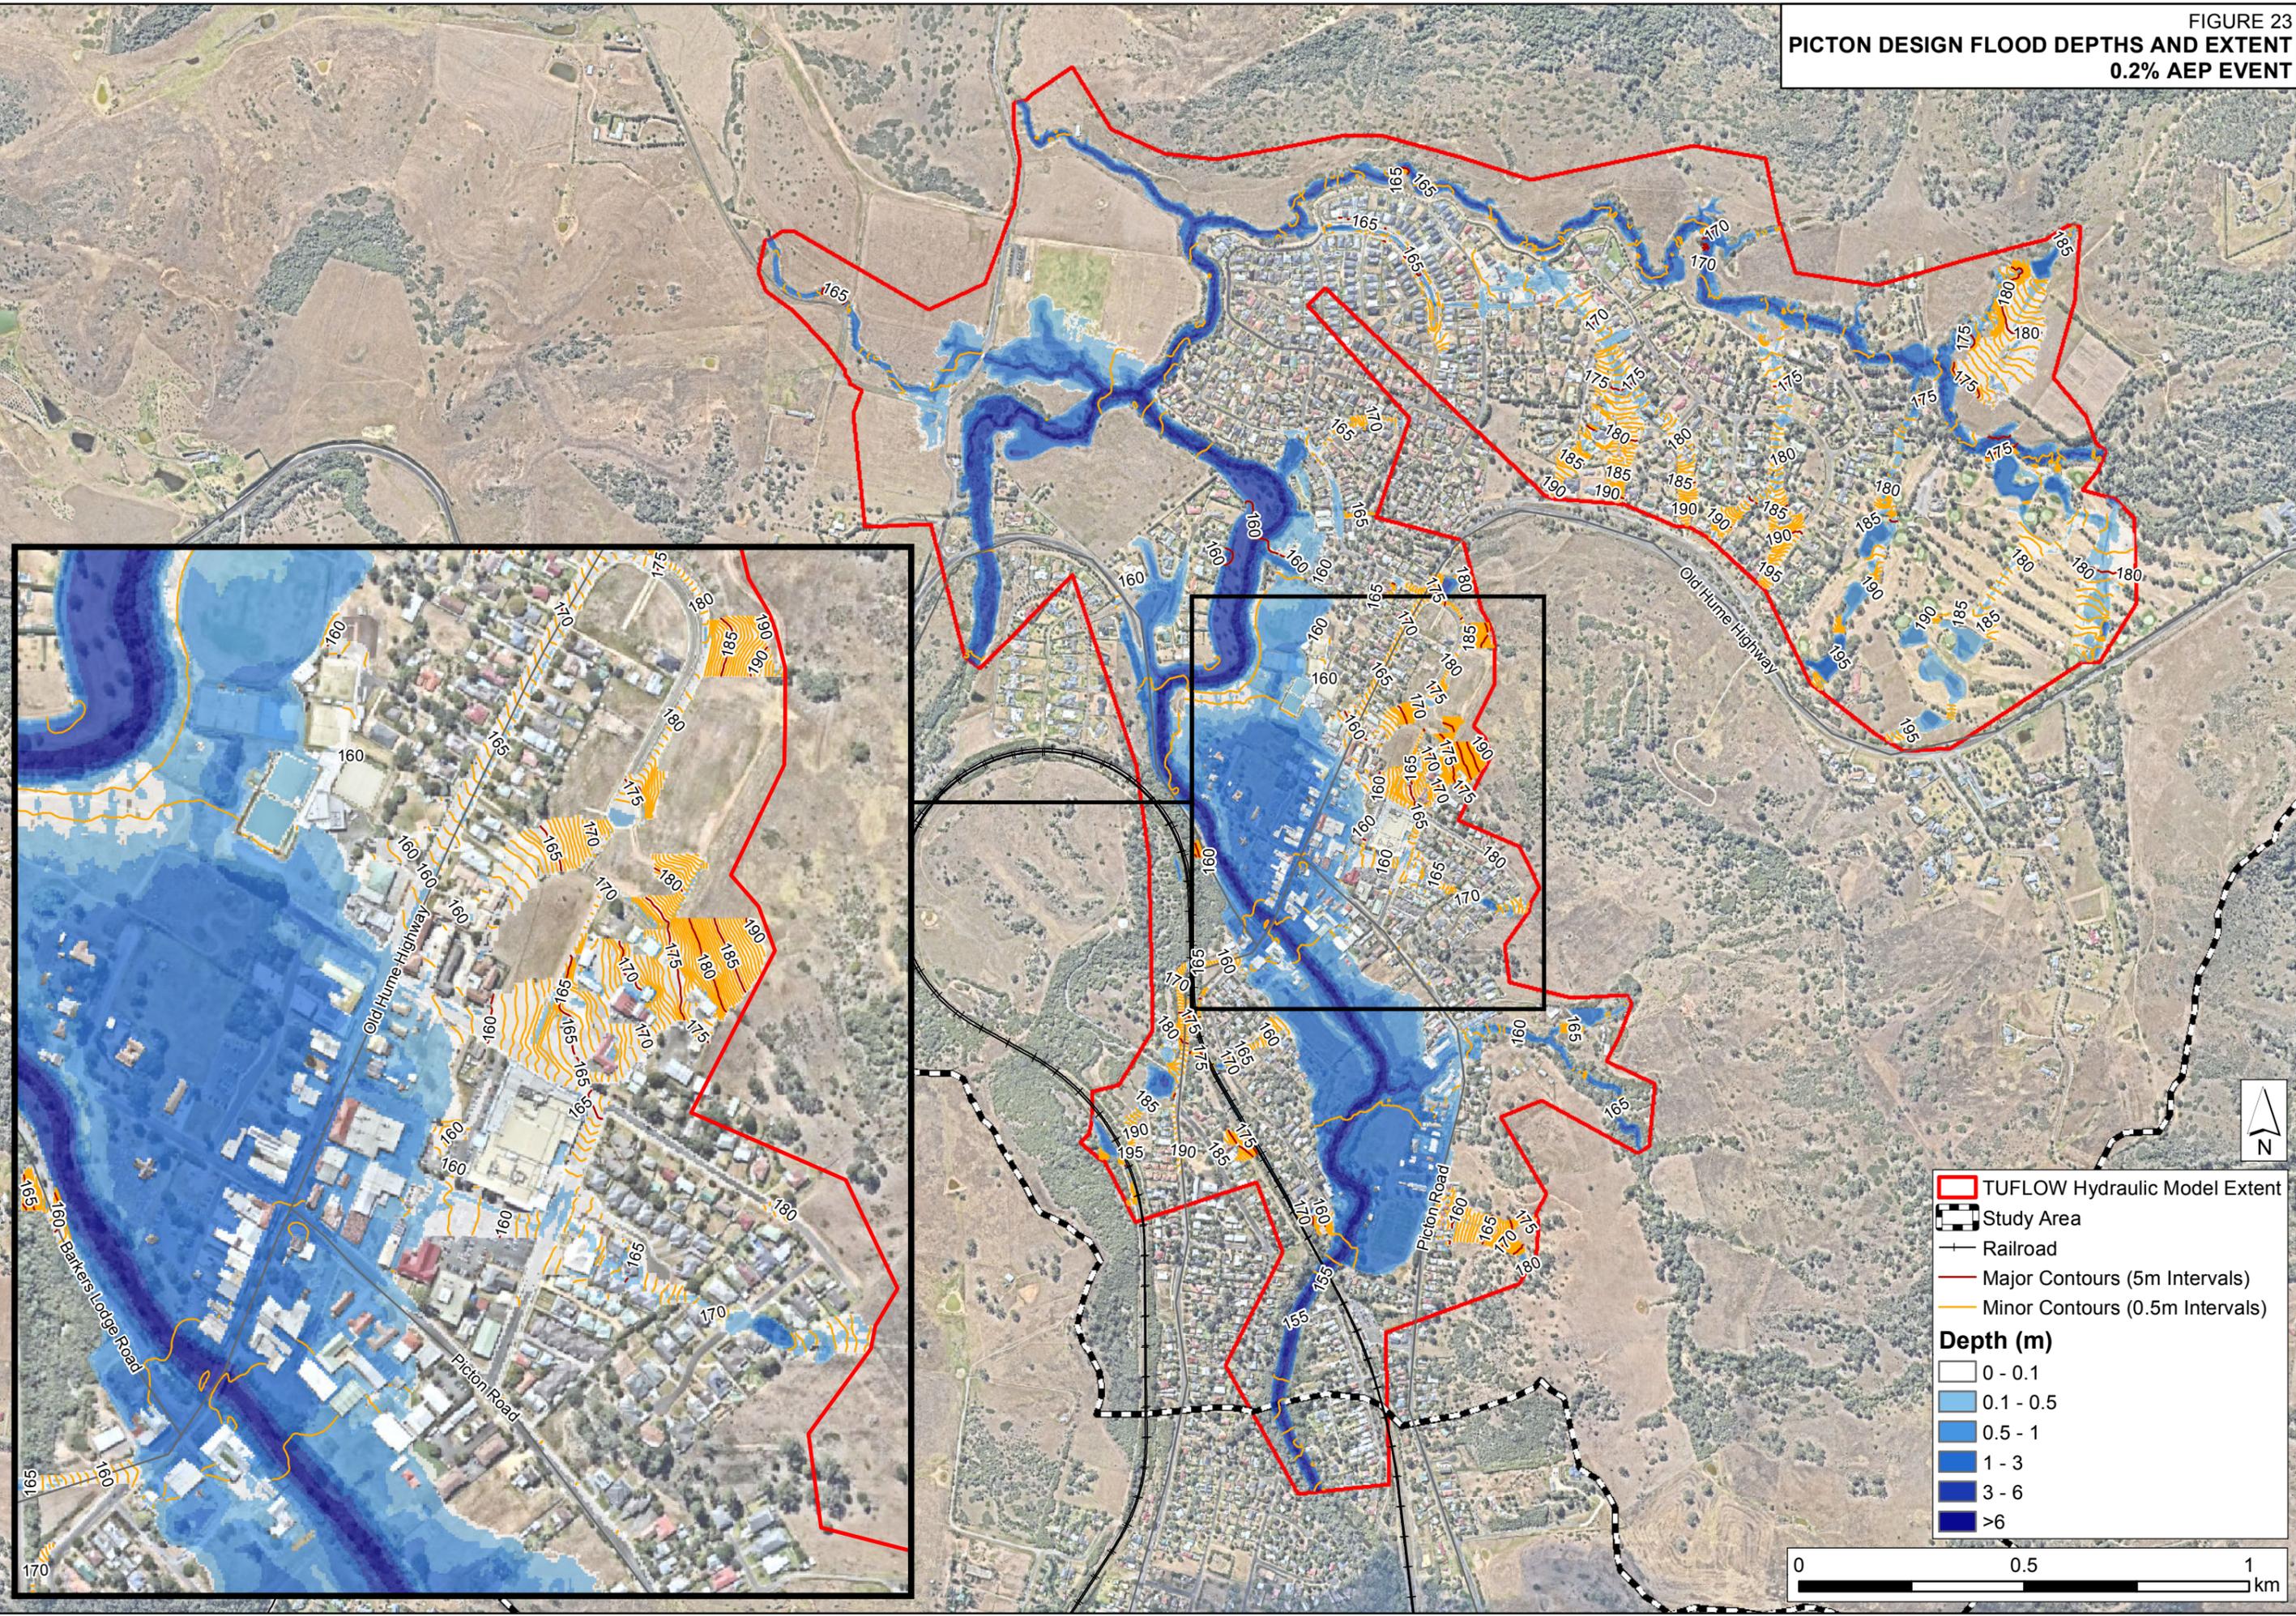
FIGURE 23
PICTON DESIGN FLOOD DEPTHS AND EXTENT
0.2% AEP EVENT

- TUFLOW Hydraulic Model Extent
- Study Area
- Railroad
- Major Contours (5m Intervals)
- Minor Contours (0.5m Intervals)

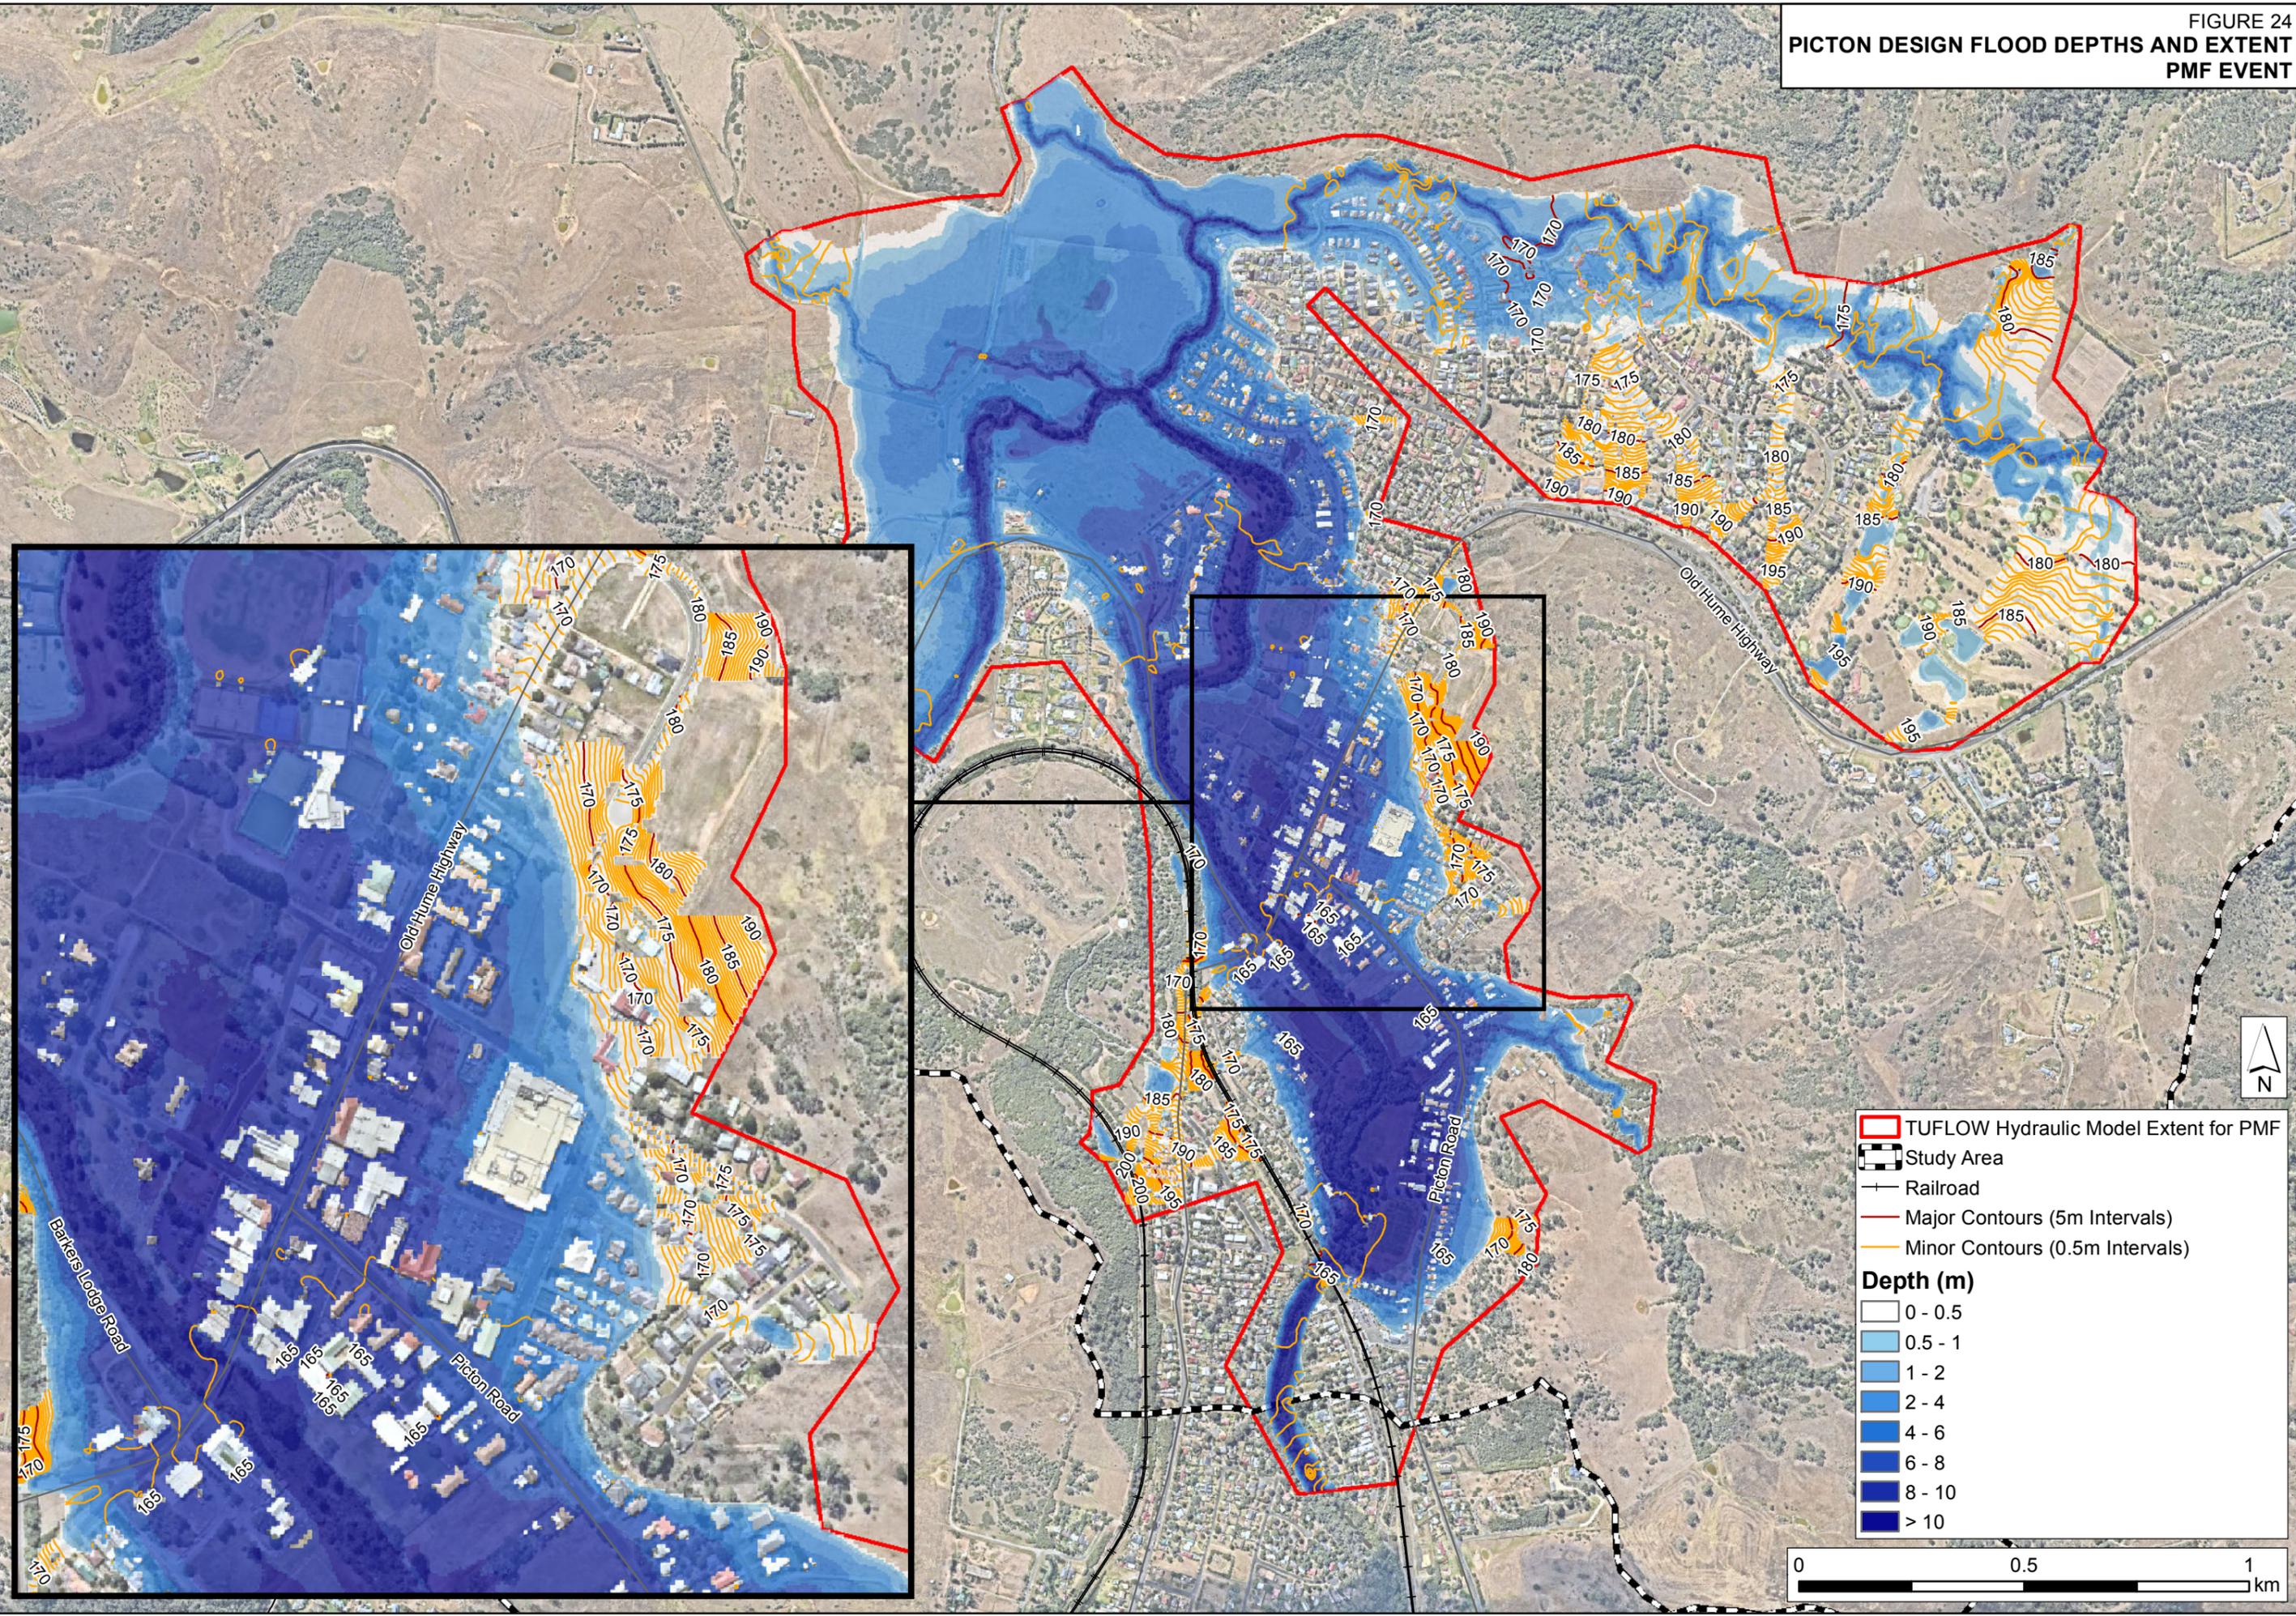
FIGURE 24
**PICTON DESIGN FLOOD DEPTHS AND EXTENT
 PMF EVENT**

TUFLOW Hydraulic Model Extent for PMF
 Study Area
 Railroad
 Major Contours (5m Intervals)
 Minor Contours (0.5m Intervals)

0 - 0.5
	0.5 - 1
	1 - 2
	2 - 4
	4 - 6
	6 - 8
	8 - 10
	> 10

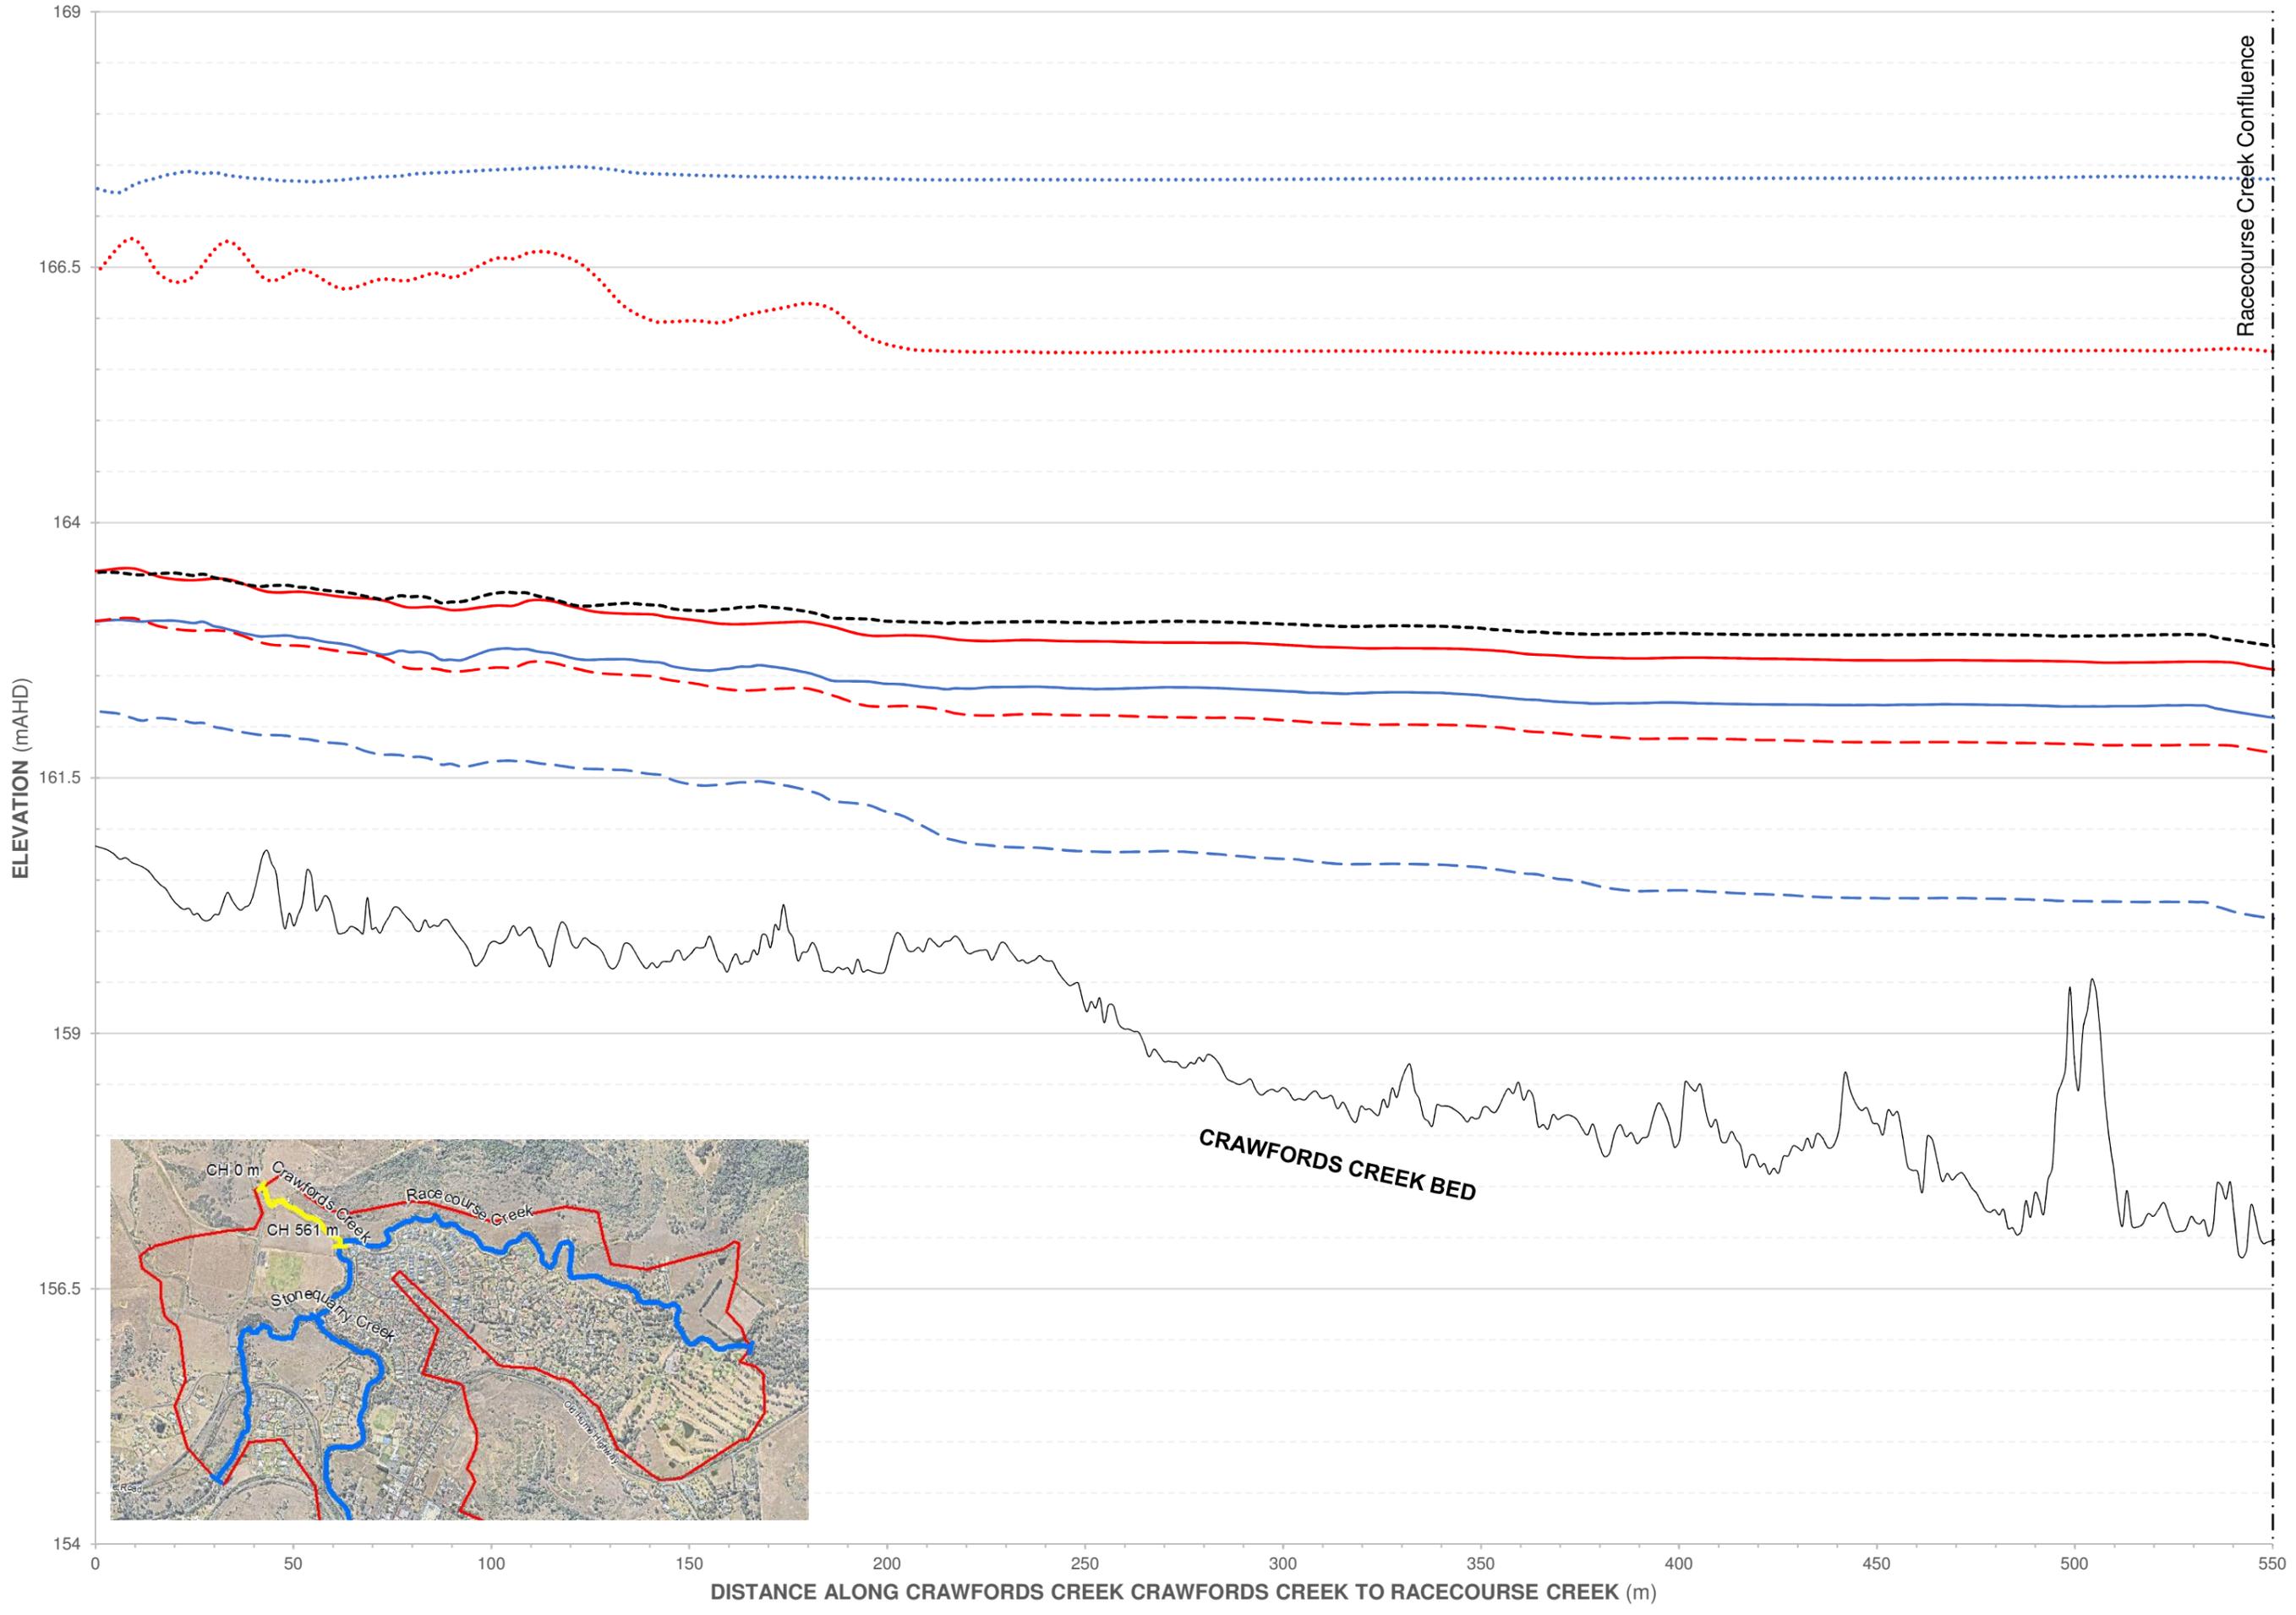
FIGURE 30
 CRAWFORDS CREEK
 PEAK WATER LEVEL PROFILE

..... TUFLOW_PMF
 —— TUFLOW_1%AEP
 - - - TUFLOW_5%AEP
 RMA-2_PMF
 —— RMA-2_1%AEP
 - - - RMA-2_5%AEP
 - - - - JUN16_Event
 —— DEM
