STONEQUARRY CREEK (PICTON) FLOOD STUDY UPDATE FINAL VOLUME II

FIGURES

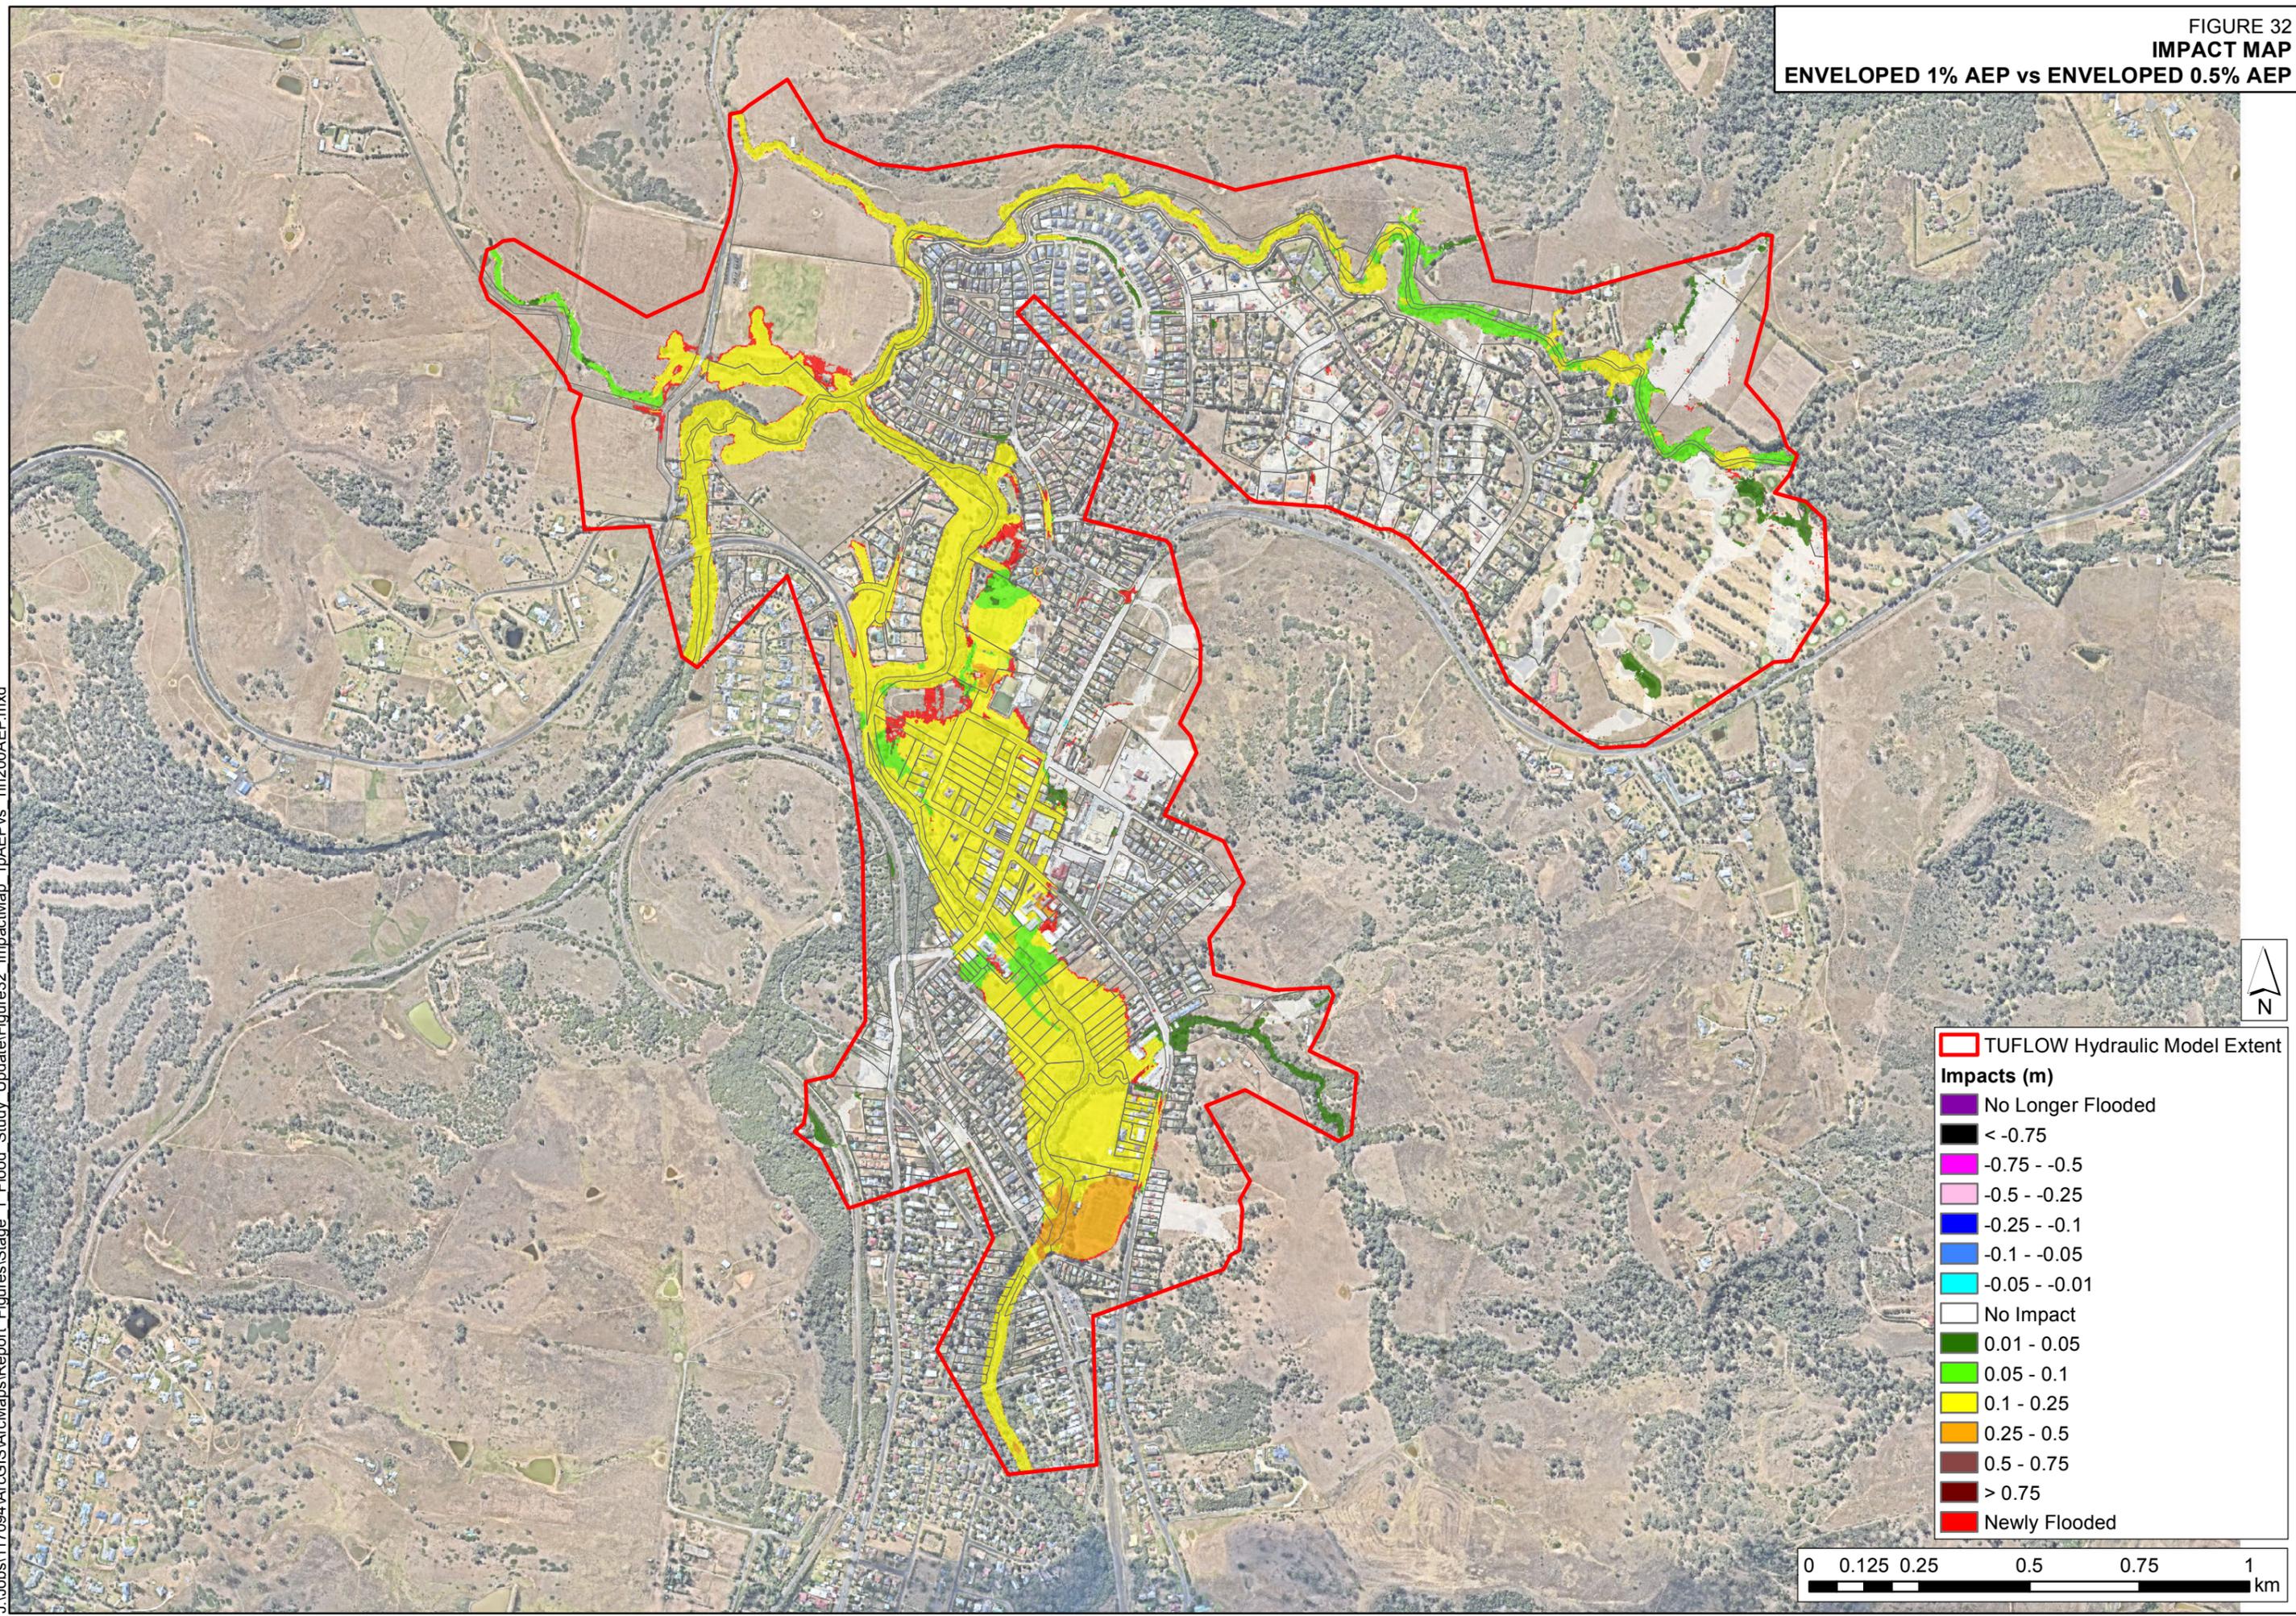
FIGURE 32
IMPACT MAP
ENVELOPED 1% AEP vs ENVELOPED 0.5% AEP

- TUFLOW Hydraulic Model Extent
- Impacts (m)**
- No Longer Flooded
- < -0.75
- 0.75 - -0.5
- 0.5 - -0.25
- 0.25 - -0.1
- 0.1 - -0.05
- 0.05 - -0.01
- No Impact
- 0.01 - 0.05
- 0.05 - 0.1
- 0.1 - 0.25
- 0.25 - 0.5
- 0.5 - 0.75
- > 0.75
- Newly Flooded

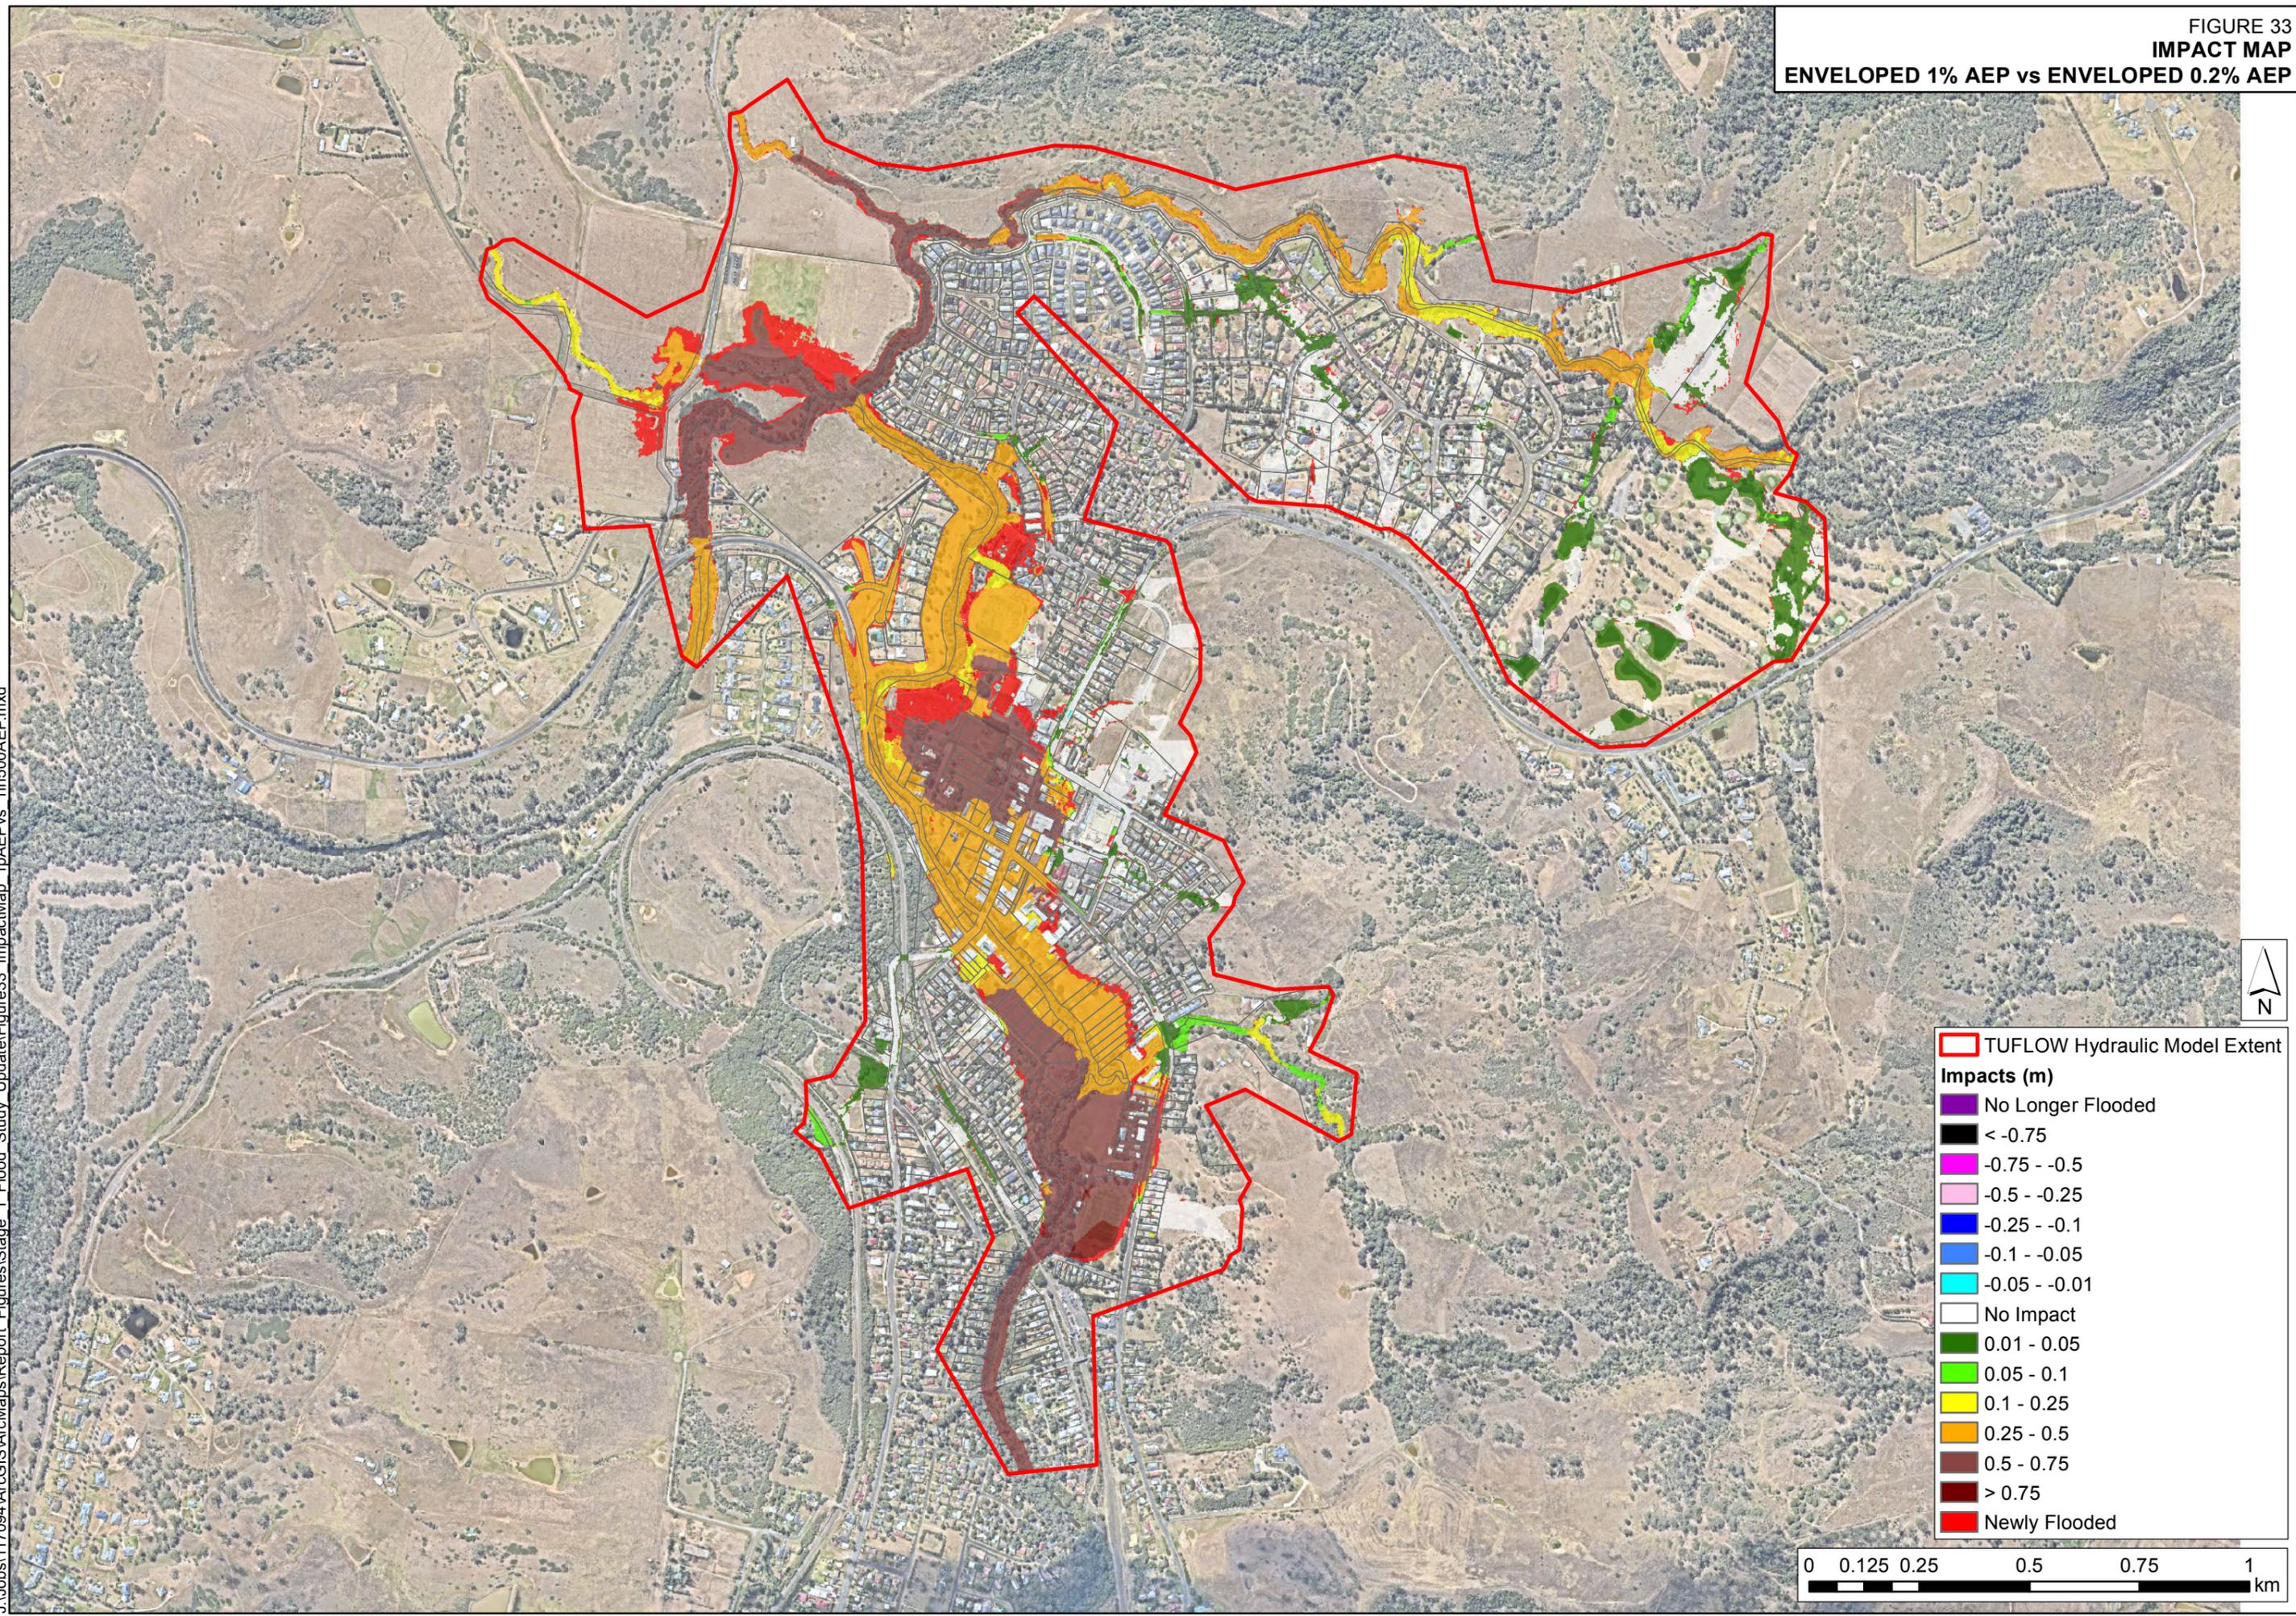
FIGURE 33
IMPACT MAP
ENVELOPED 1% AEP vs ENVELOPED 0.2% AEP

- TUFLOW Hydraulic Model Extent
- Impacts (m)**
- No Longer Flooded
- < -0.75
- 0.75 - -0.5
- 0.5 - -0.25
- 0.25 - -0.1
- 0.1 - -0.05
- 0.05 - -0.01
- No Impact
- 0.01 - 0.05
- 0.05 - 0.1
- 0.1 - 0.25
- 0.25 - 0.5
- 0.5 - 0.75
- > 0.75
- Newly Flooded

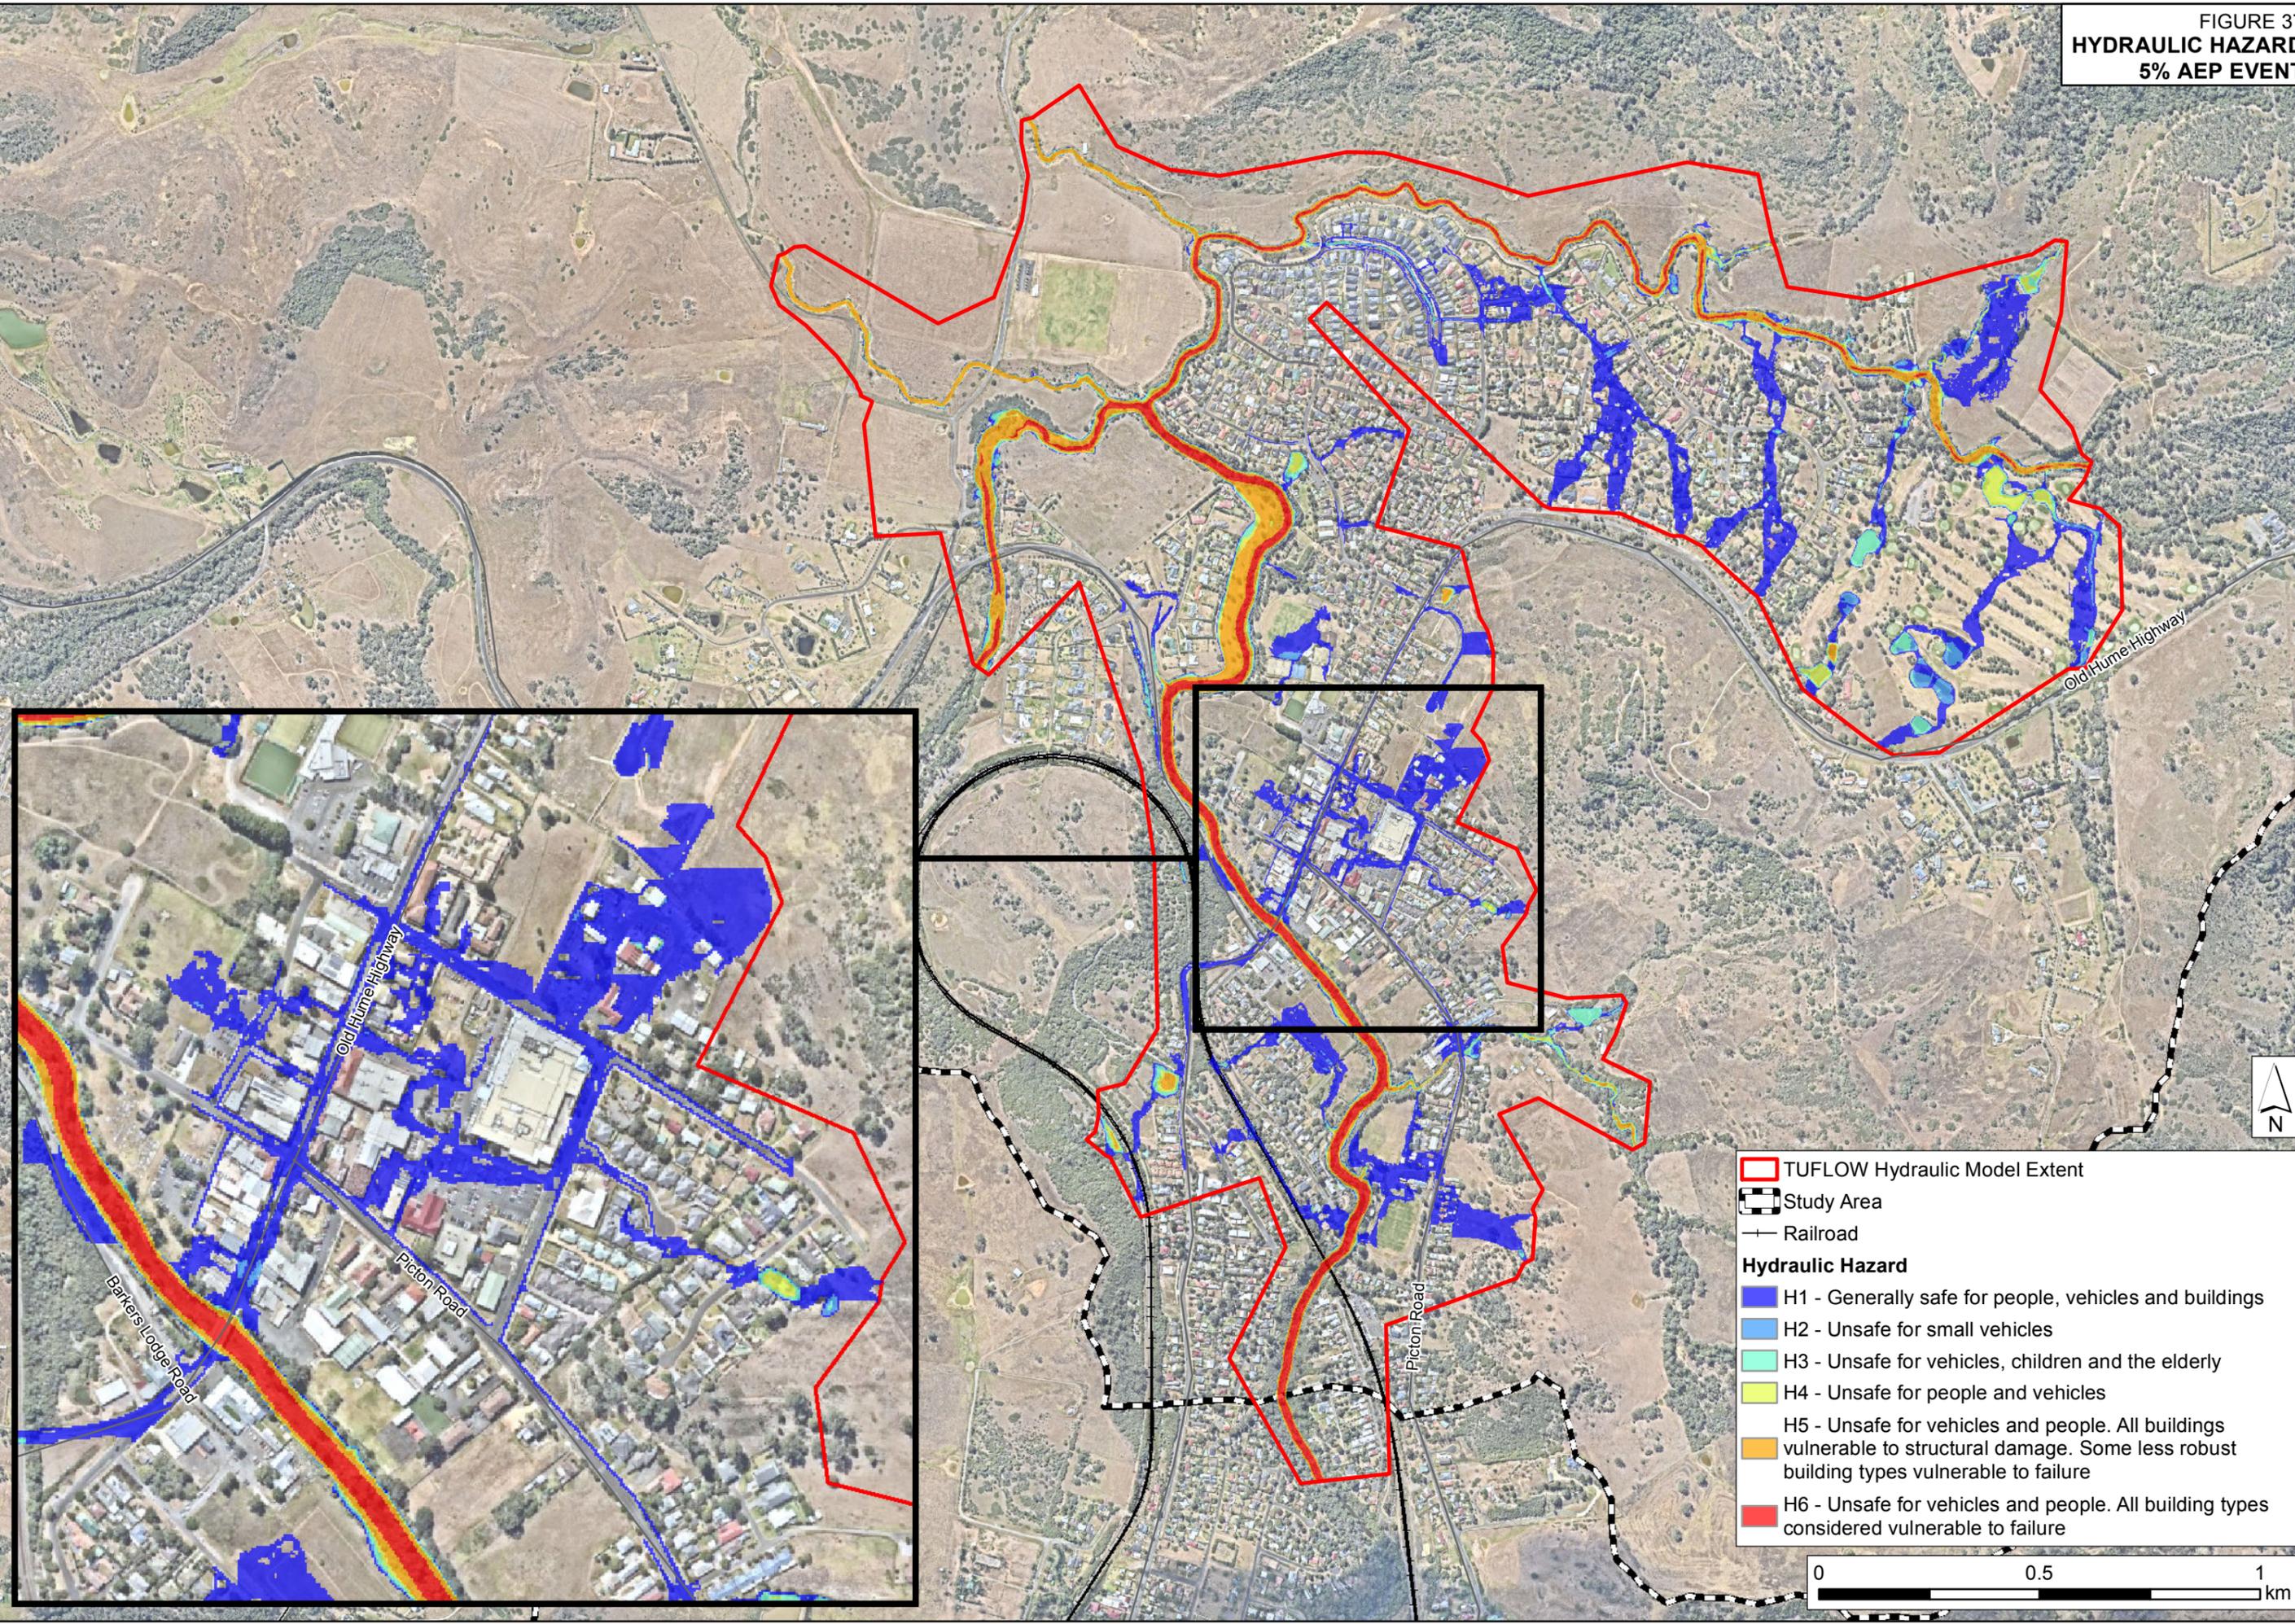
FIGURE 37
 HYDRAULIC HAZARD
 5% AEP EVENT

Hydraulic Hazard

- H1 - Generally safe for people, vehicles and buildings
- H2 - Unsafe for small vehicles
- H3 - Unsafe for vehicles, children and the elderly
- H4 - Unsafe for people and vehicles
- H5 - Unsafe for vehicles and people. All buildings vulnerable to structural damage. Some less robust building types vulnerable to failure
- H6 - Unsafe for vehicles and people. All building types considered vulnerable to failure

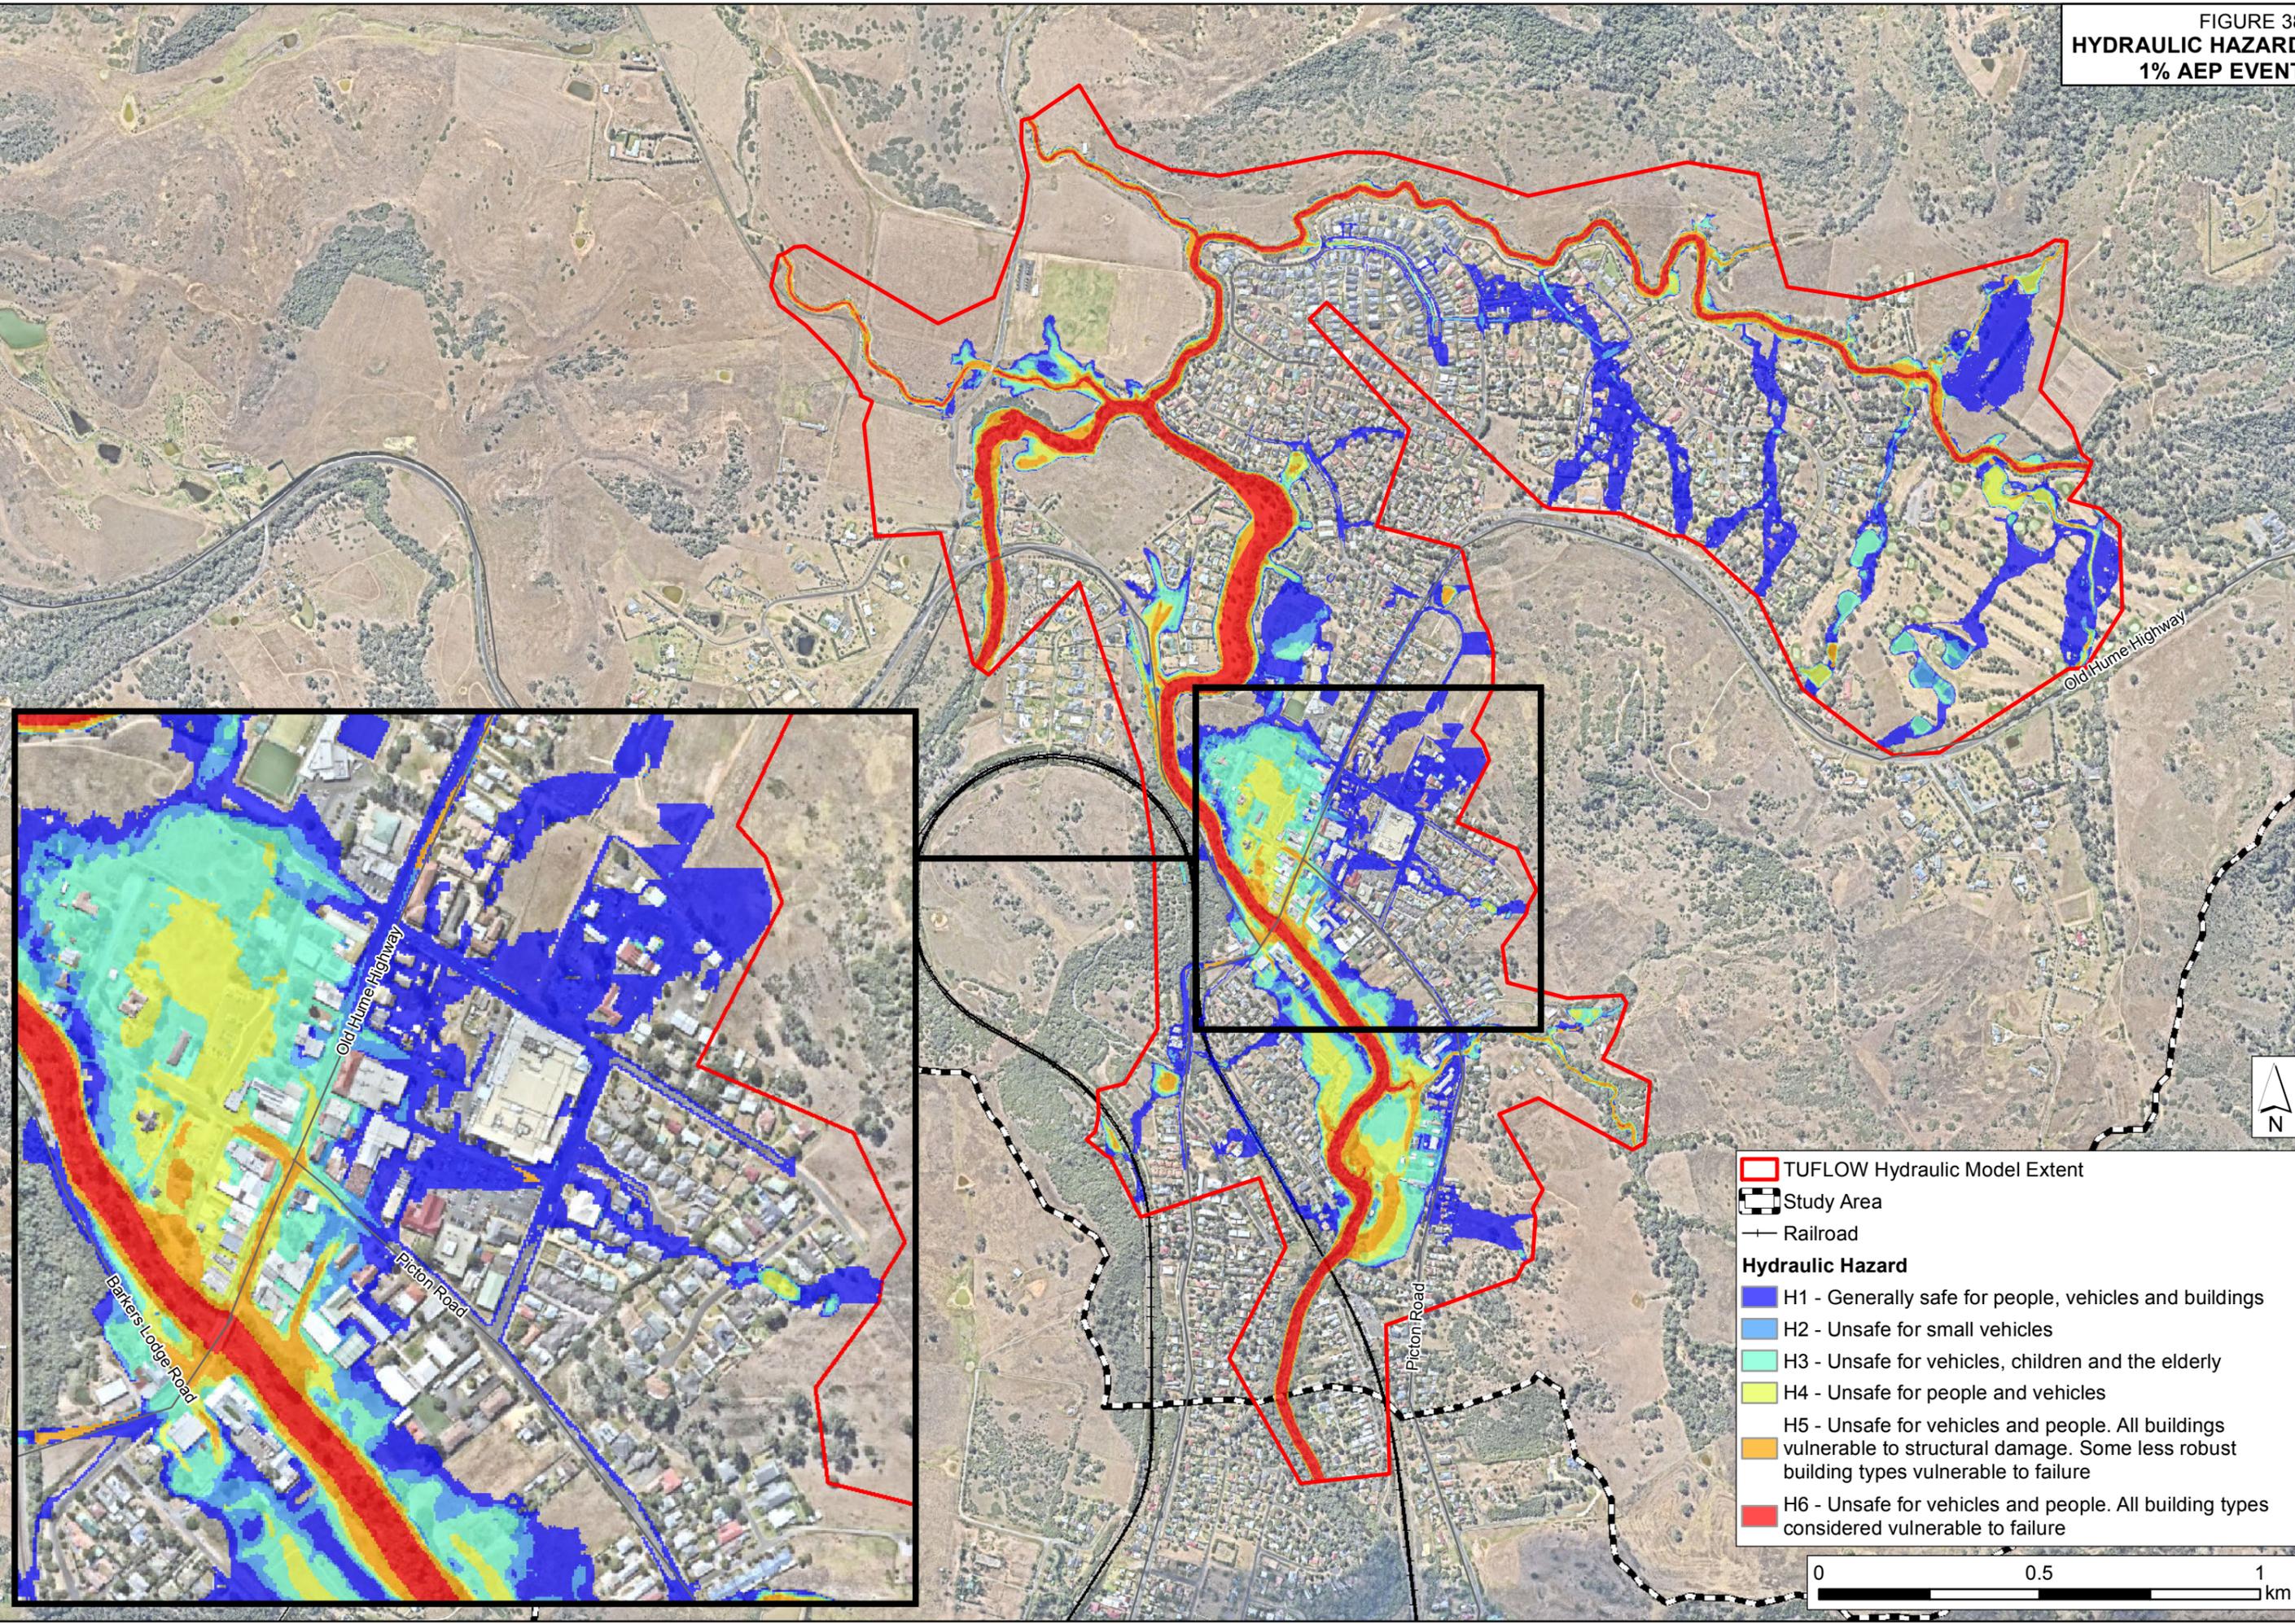
FIGURE 38
HYDRAULIC HAZARD
1% AEP EVENT

Hydraulic Hazard

- H1 - Generally safe for people, vehicles and buildings
- H2 - Unsafe for small vehicles
- H3 - Unsafe for vehicles, children and the elderly
- H4 - Unsafe for people and vehicles
- H5 - Unsafe for vehicles and people. All buildings vulnerable to structural damage. Some less robust building types vulnerable to failure
- H6 - Unsafe for vehicles and people. All building types considered vulnerable to failure
